AGENDA
HISTORIC PRESERVATION BOARD
Lakeland City Hall, City Commission Chambers
June 25, 2026, 8:30 A.M.

BOTH PRESENTATIONS TO BE HELD IMMEDIATELY FOLLOWING DESIGN REVIEW COMMITTEE MEETING
- V. Adjourn for Design Review Committee

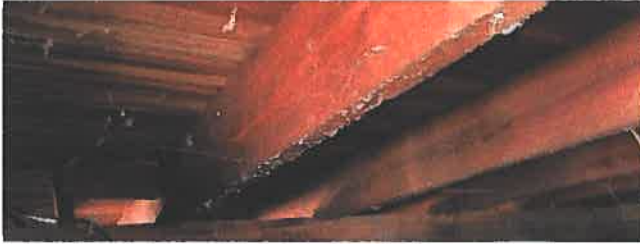
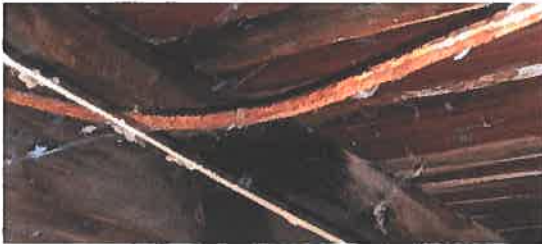
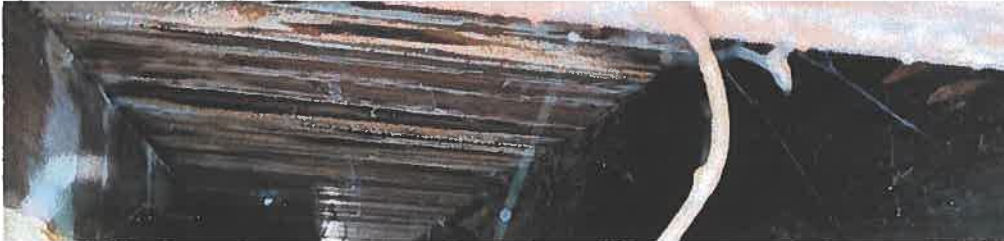
The next pictures are examples of floors that are damaged from termite and age rot.

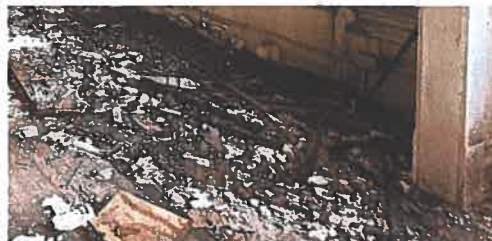
Below are examples of floor damage as seen in the rooms. The carpet in the 3rd picture is hiding multiple areas where the floor gives and if the carpet was removed, there would be holes in the floor.

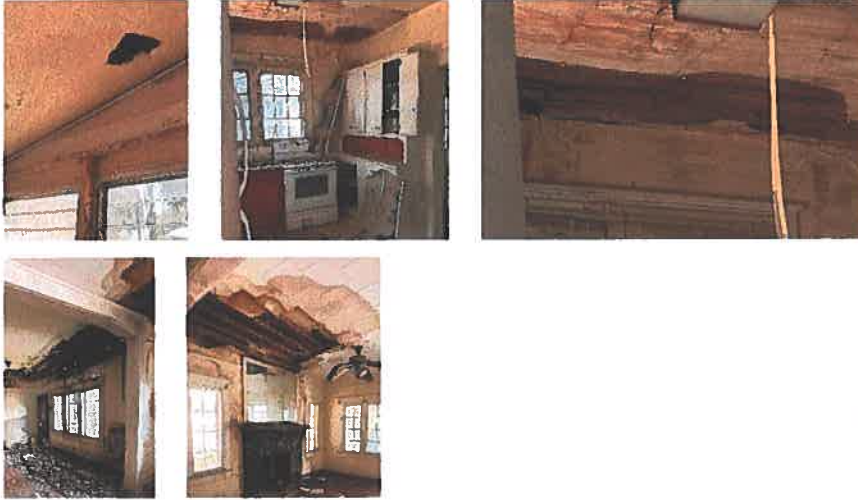
The pictures below are just examples of ceiling damage and representative of the danger that the ceiling presents to anyone who is in the house. The ceiling could fall, without warning, and hurt someone who happens to be under it.

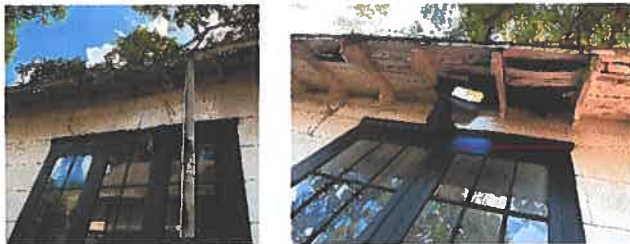
There is evidence that multiple areas of the roof decking have been replaced, however, the major concern is with the ceiling attachments, followed by the ceiling beams. Below are pictures of tree branch damage, Picture 1, and moisture rot, Picture 2.

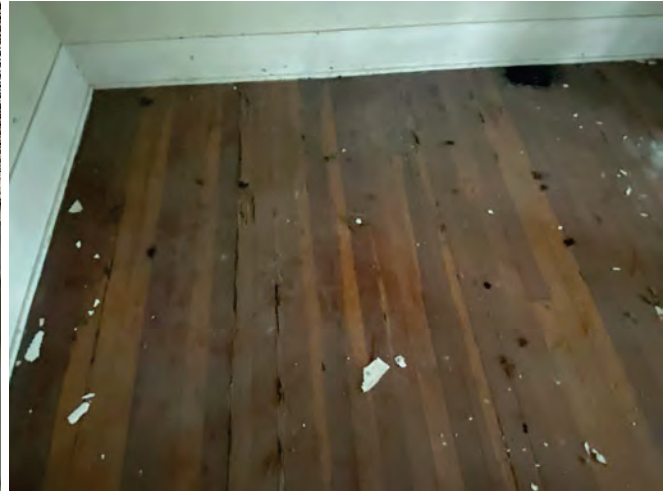
Termite Damage & Frass in NE Bedroom

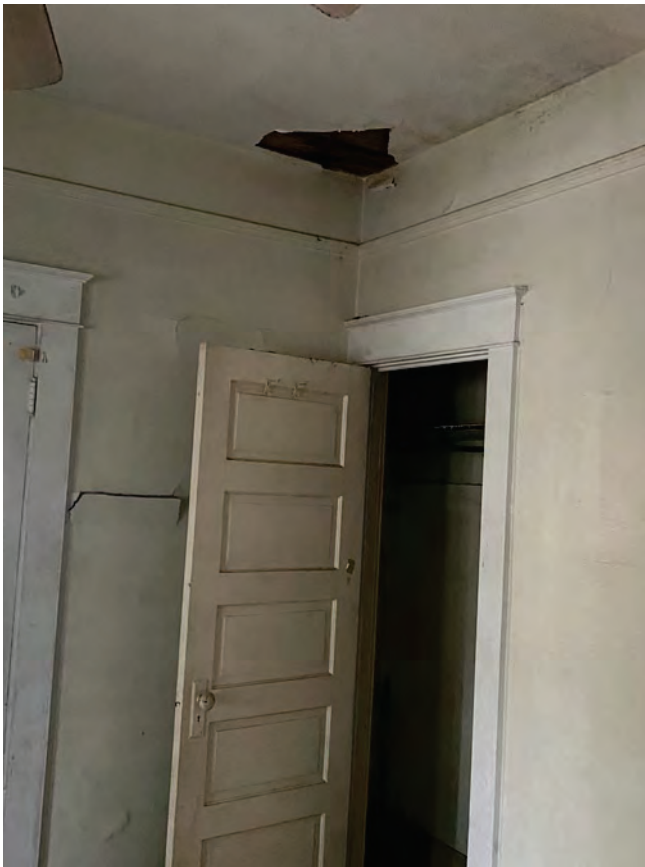
Bedroom Ceiling Damage

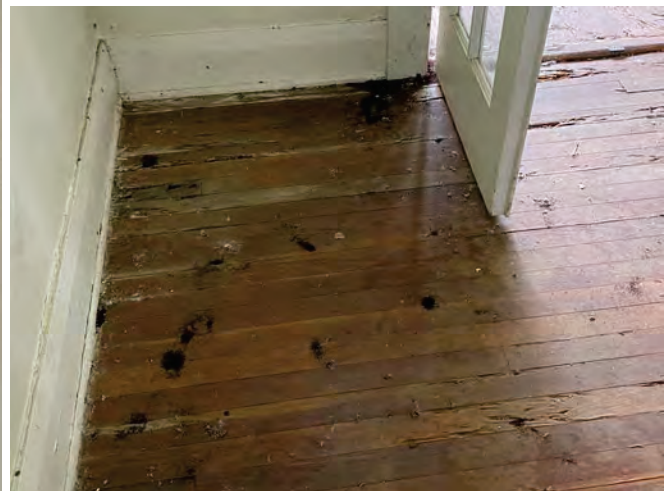
Bedroom Floor Damage & Termite Frass

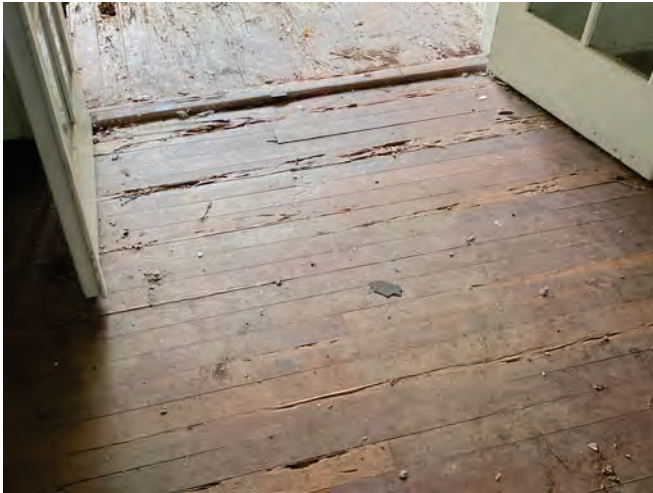
Termite Damage in Bedroom Floor

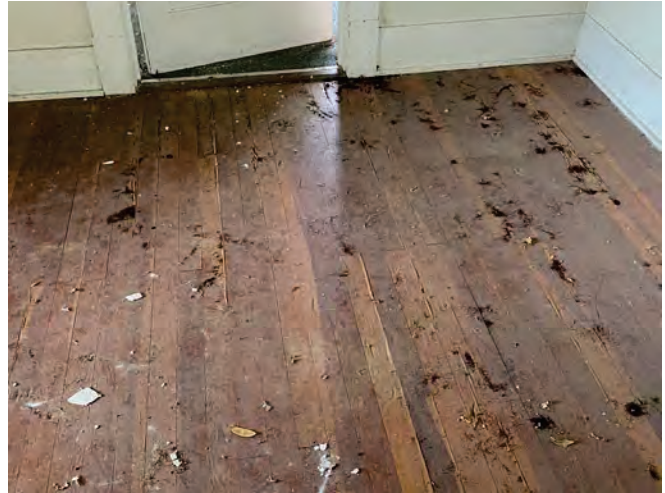
Termite Damage/Frass in Bedroom Floor

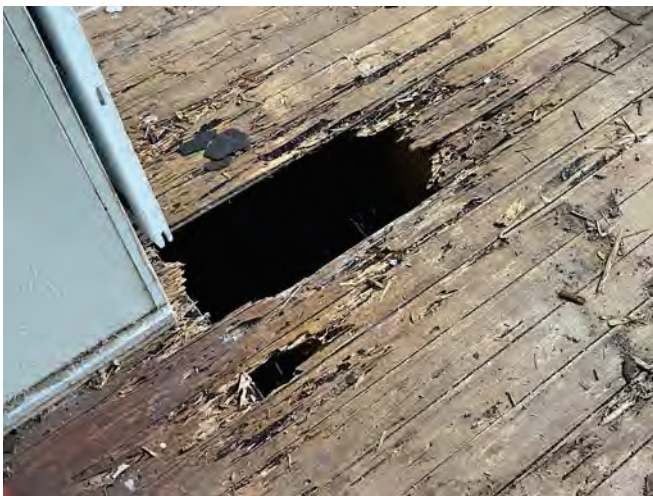
Termite Damage in East Sunroom Floor

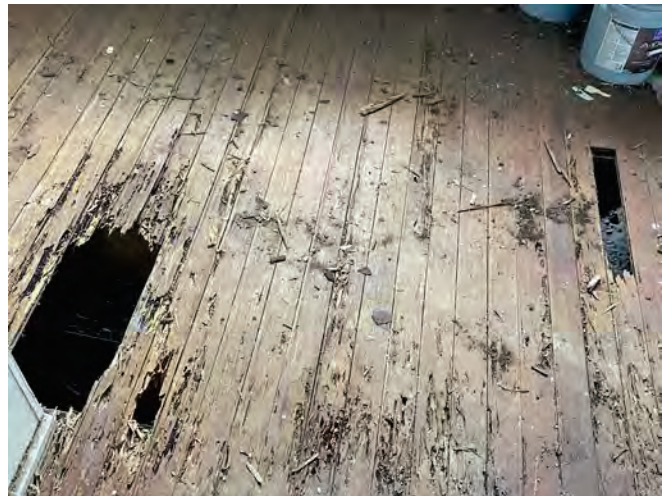
Termite Damage in East Sunroom Floor

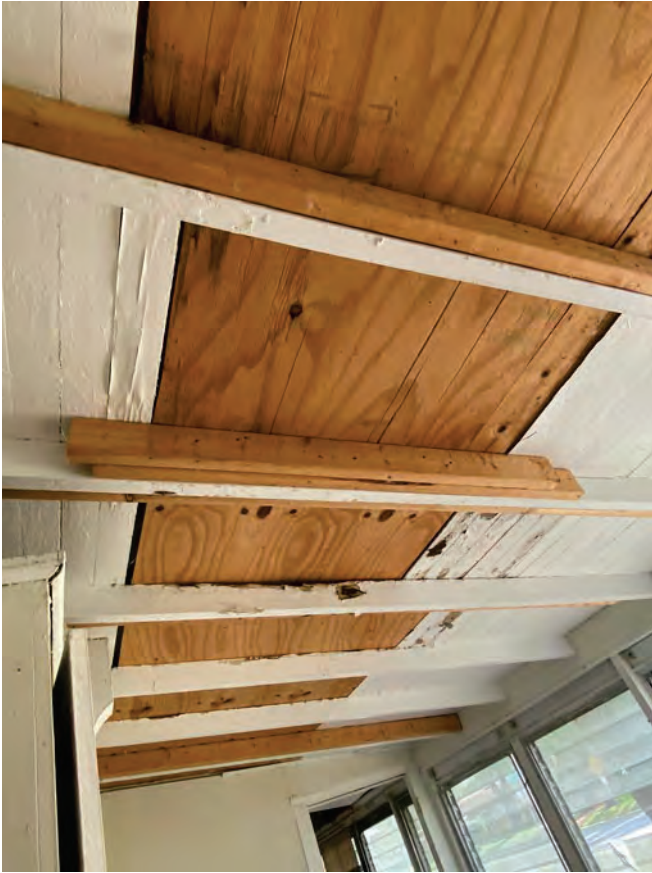
Prior Repairs to Sunroom Roof Framing

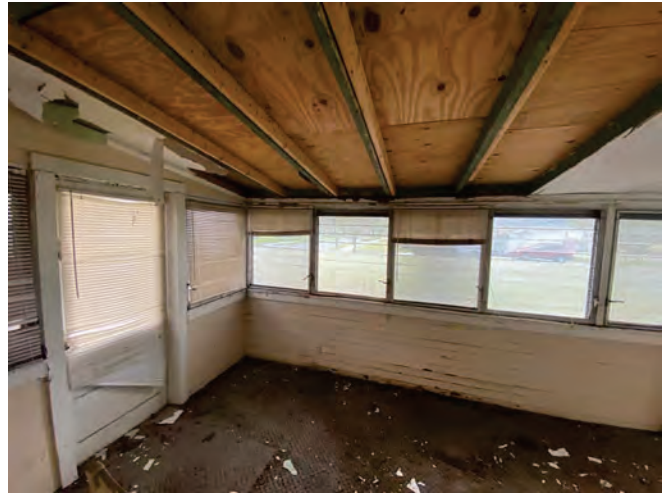
Prior Sunroom Roof Repairs & Floor Damage

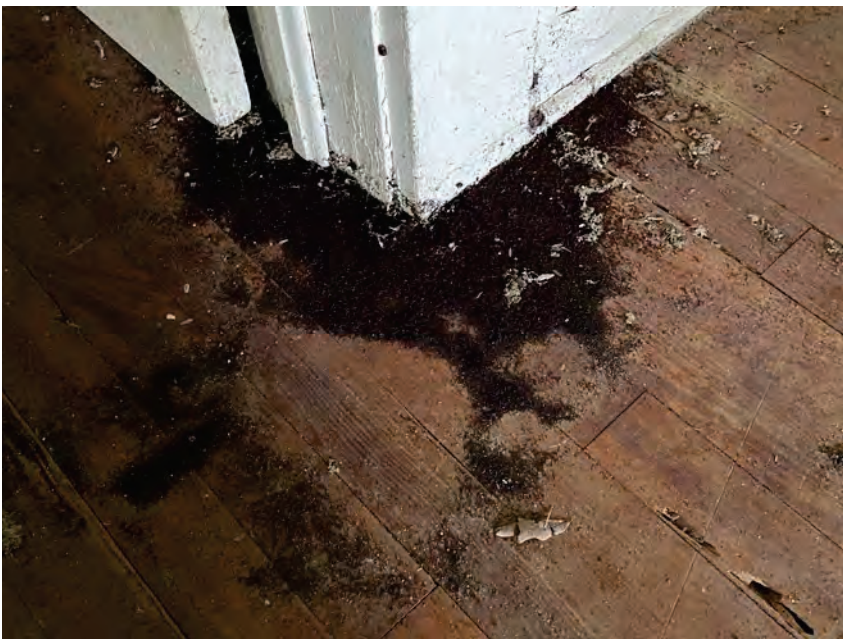
Drywood Termite Frass

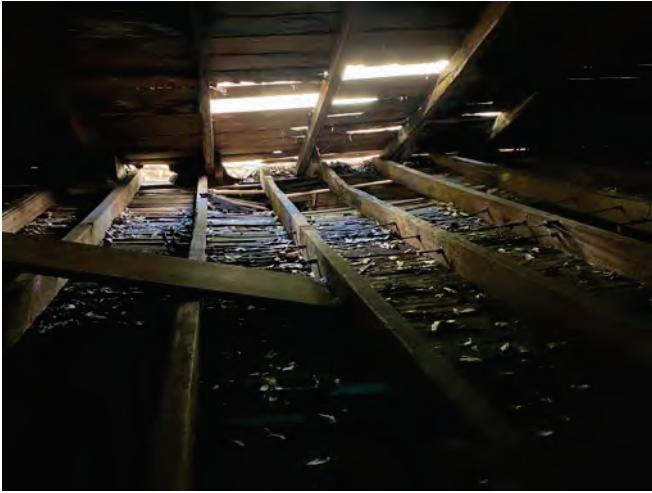
Roof/Ceiling Damage above Living Room

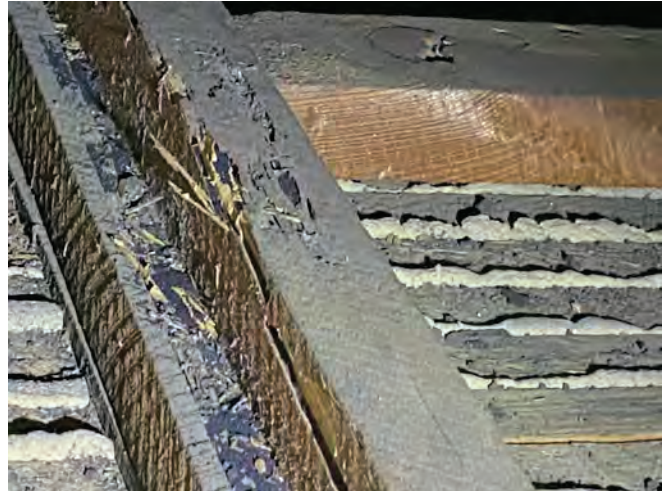
Termite Damage in Ceiling Framing

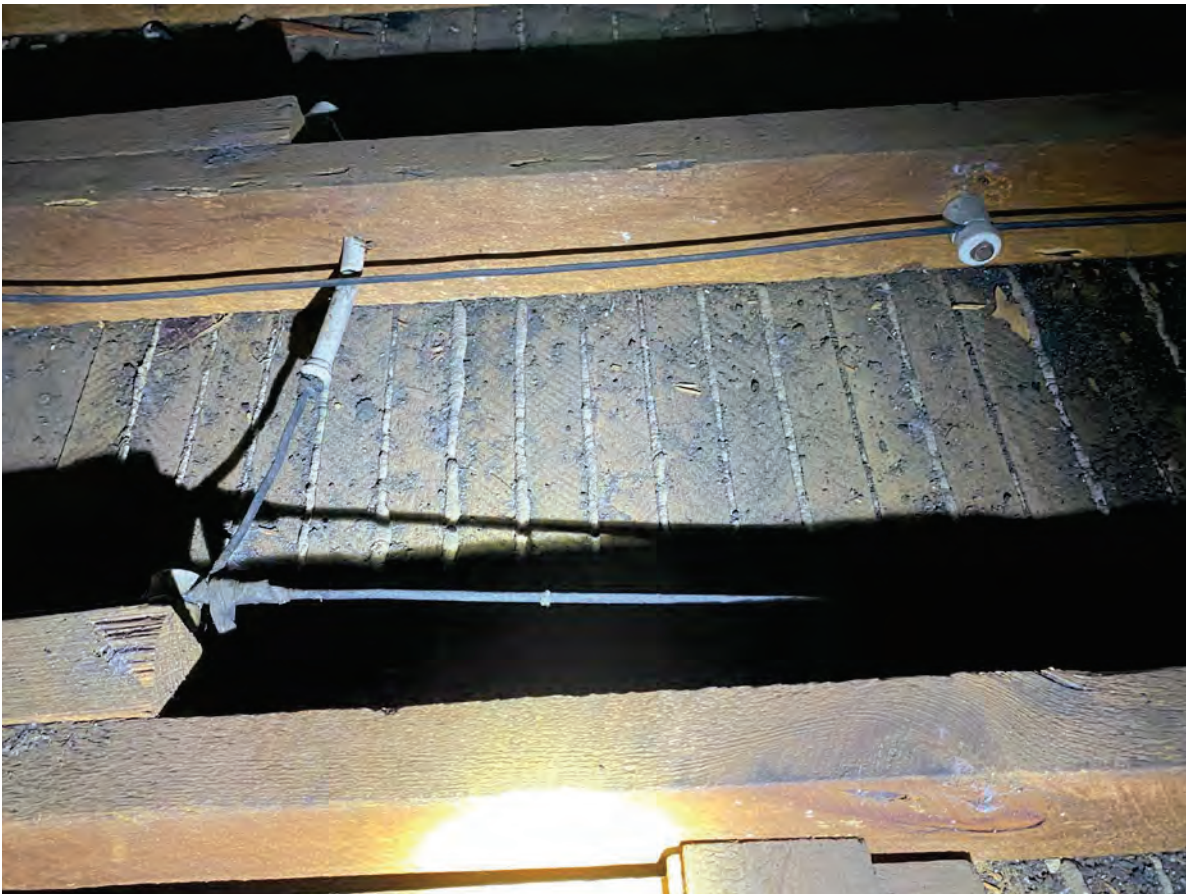
Knob-N-Tube Electrical Wiring in Attic

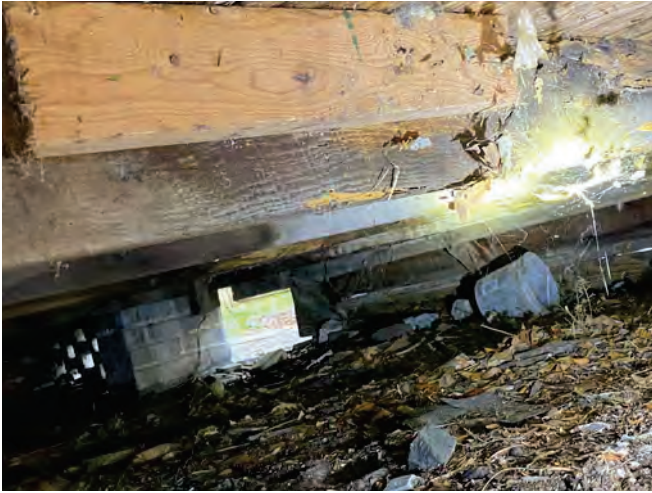
Floor Joist Damage & Prior Repair

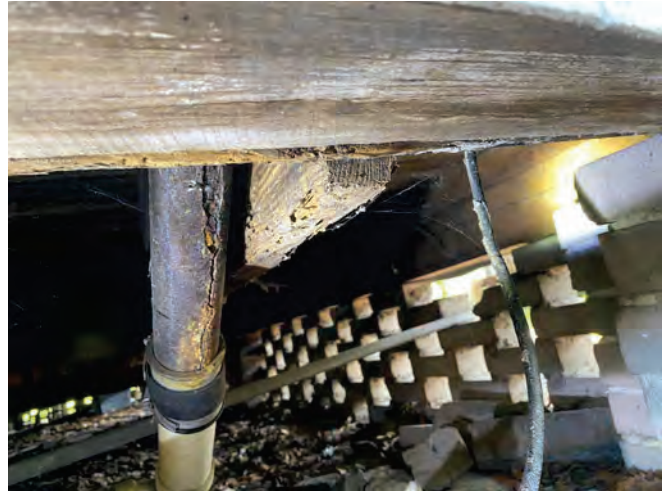
Floor Joist Damage & Rusted Out Plumbing

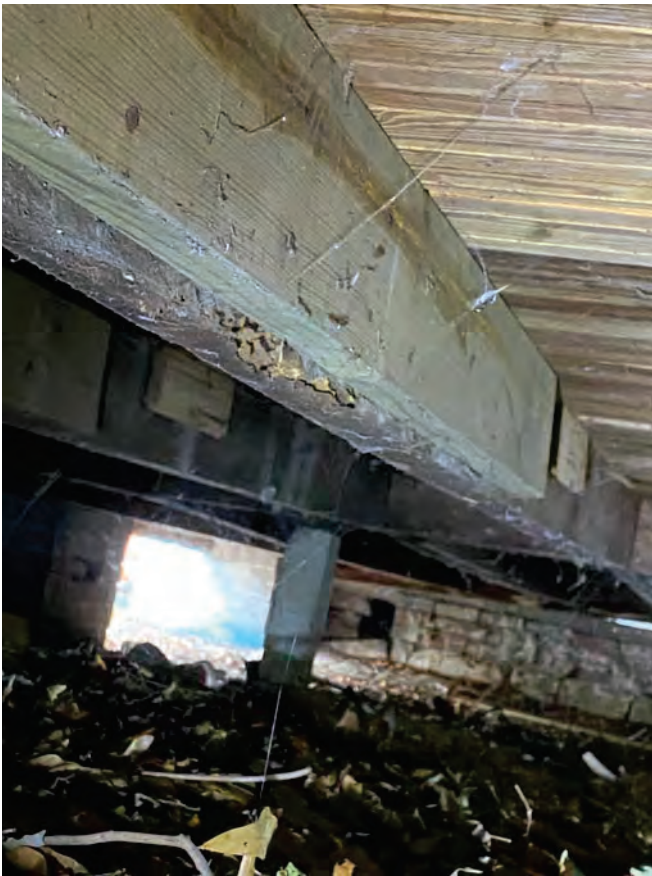
Damaged/Repaired Floor Joist

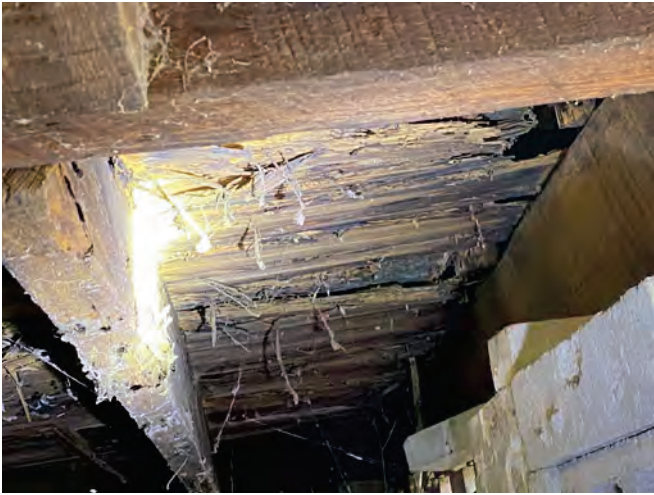
Damaged Floor Joist & Decking

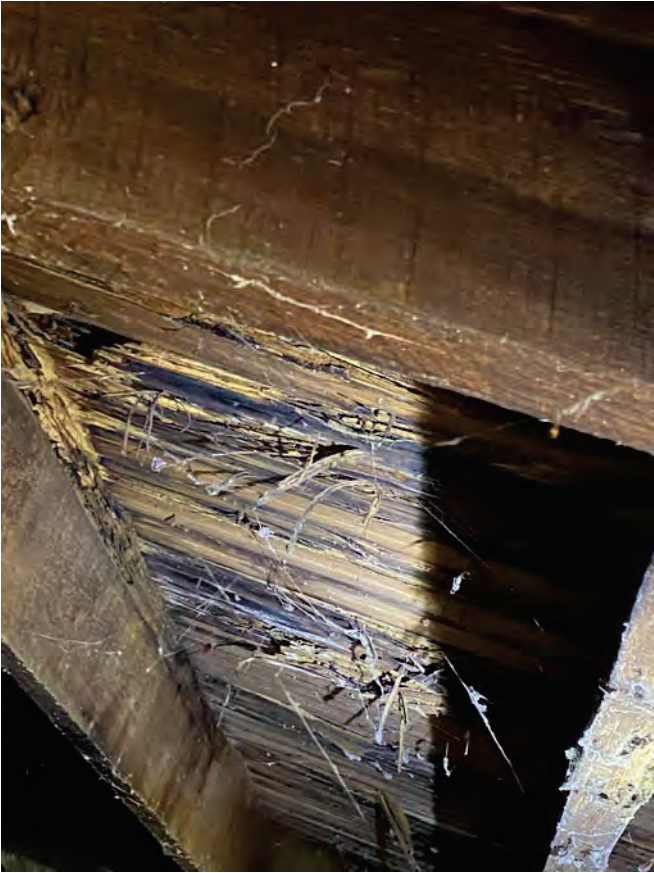
Damaged Floor Decking

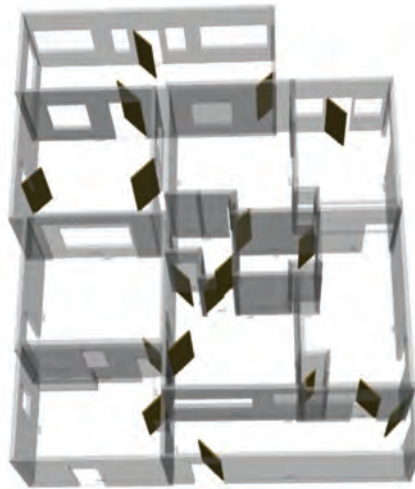
Figure 1: Three-dimensional wall-and-opening model of the dwelling, prepared from Room Scanner© by Chris Woods

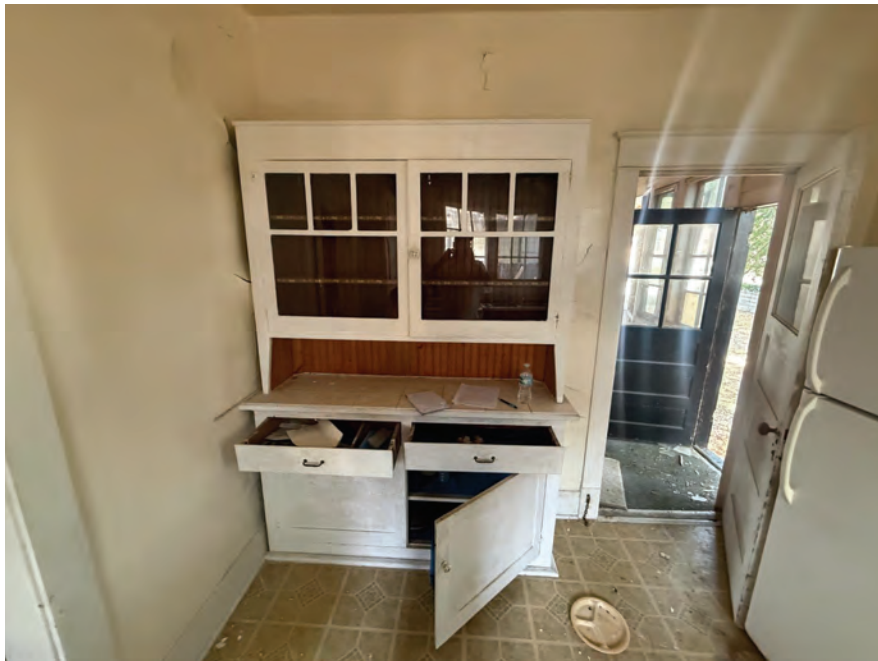
Figure 2: Built-in kitchen cabinet — multi-light glass-front upper doors, beadboard back, tile counter, drawers and lower cabinets.
Photo taken by Chris Woods.

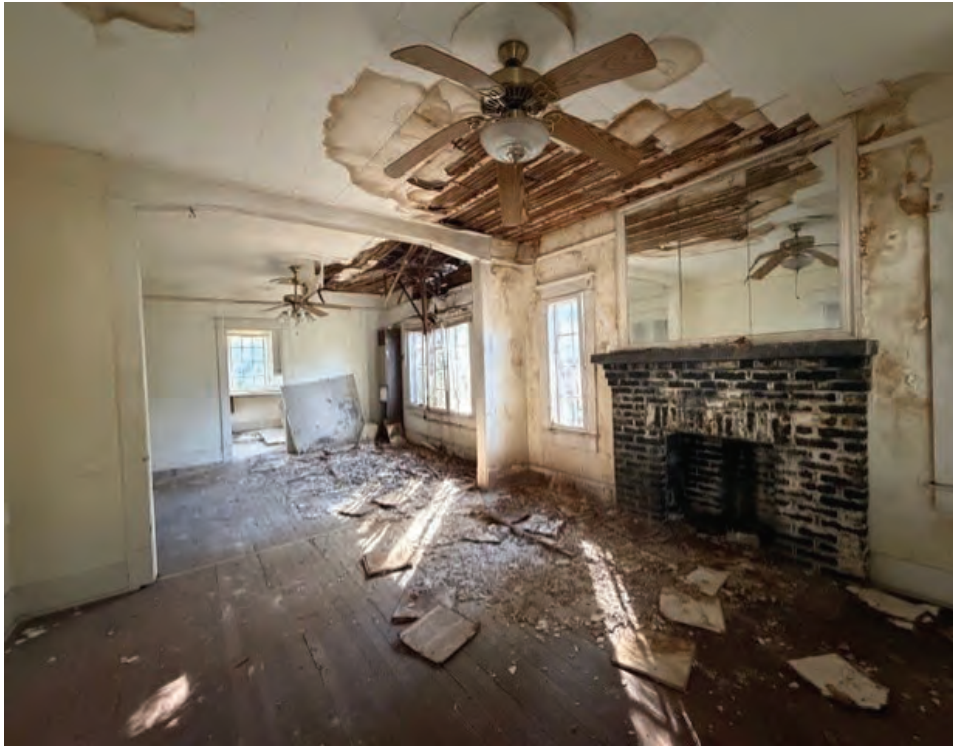
Figure 3: Interior wall in a principal room; window air-conditioner cut into wall between original wood windows, debris on floor, chimney mass at right. Photo taken by Chris Woods.

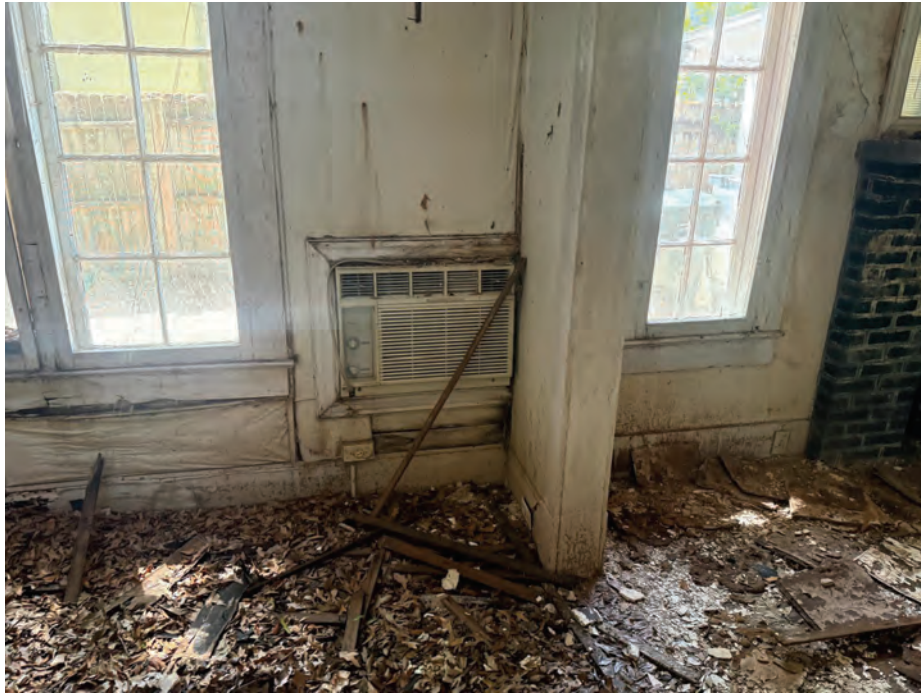
Figure 4: Another photo of interior wall in a principal room; window air-conditioner cut into wall between original wood windows, debris on floor, chimney mass at right. Photo taken by Chris Woods.

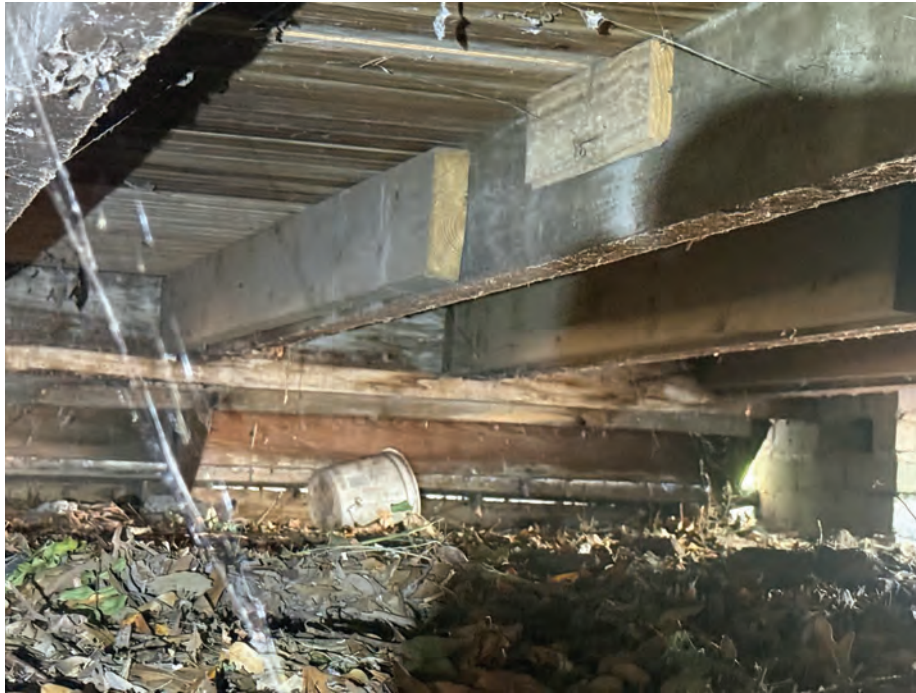
Figure 5: Floor framing from the crawlspace; original wood joists and beam with newer sister-board reinforcement (lighter, square-cut members). Photo taken by Chris Woods. Photo taken by Chris Woods.

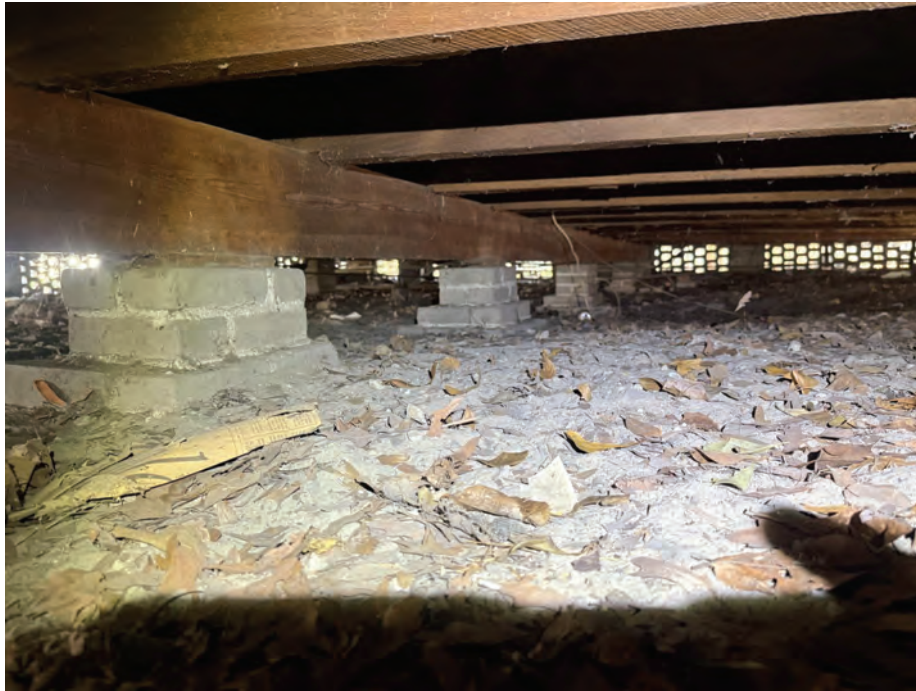
*Figure 6: Crawlspace looking across the structure; concrete-block piers, soil floor with leaf litter, perimeter foundation vents at right.
Photo taken by Chris Woods.*

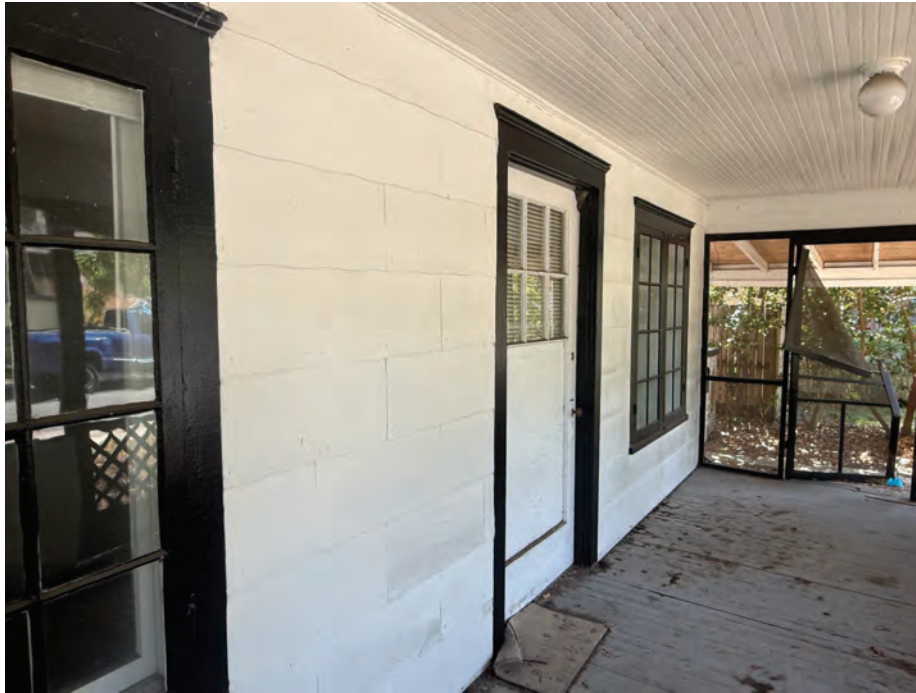
Figure 7: Inside the screened front porch; original wood-board siding, multi-light wood door and window, original beadboard ceiling, wood porch floor. Photo taken by Chris Woods.

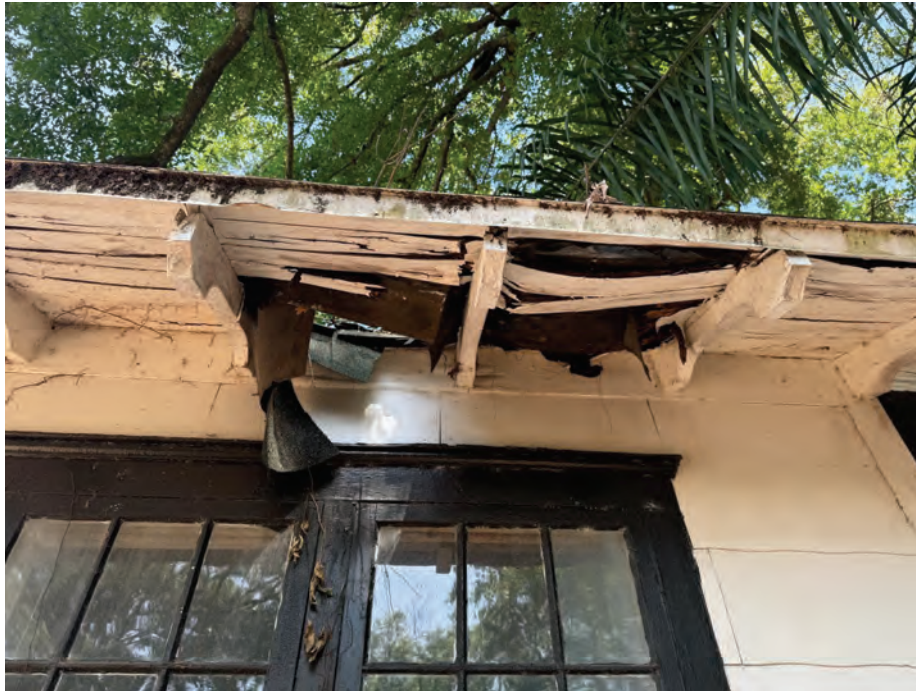
Figure 8: Eave above the windows; failed cornice and soffit between rafter tails, dropped roofing material, vegetation. Photo taken by Chris Woods.

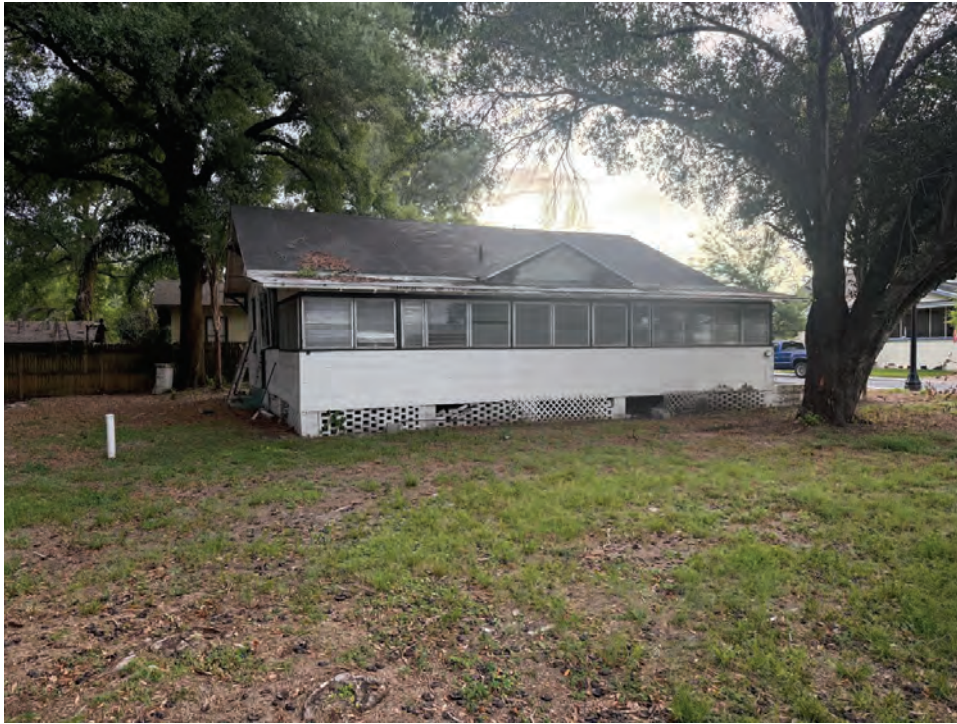
Figure 9: East elevation; non-historic enclosed side porch with CMU foundation and jalousie windows, set against the original wood-frame house behind. Photo taken by Chris Woods.

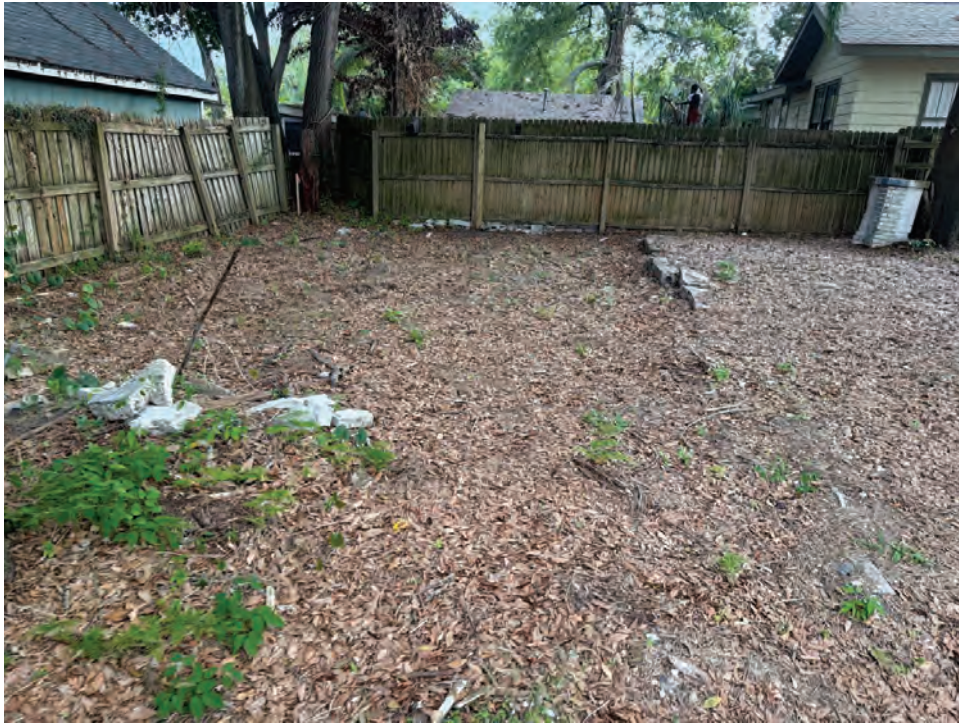
Figure 10: Rear yard looking south; bare soil and leaf litter, wood privacy fencing on three sides, scattered masonry debris. Photographed by Chris Woods.

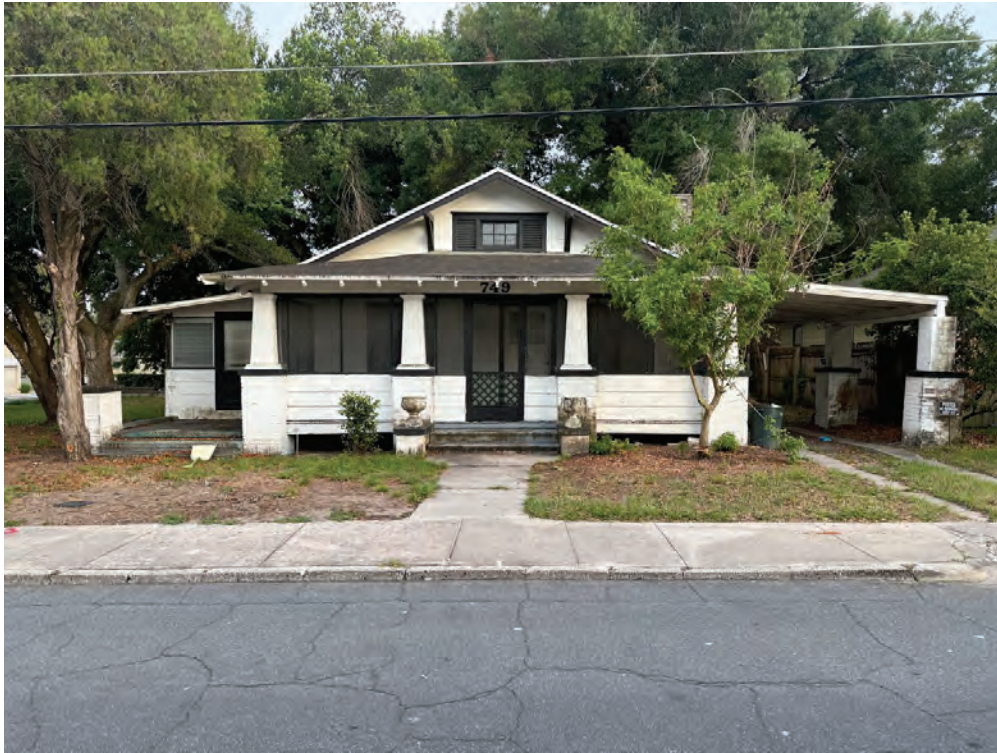
Figure 11: Front (street) elevation; Craftsman bungalow with twin tapered pier columns over brick piers, screened porch behind, attic vent in main gable, mature oak canopy.

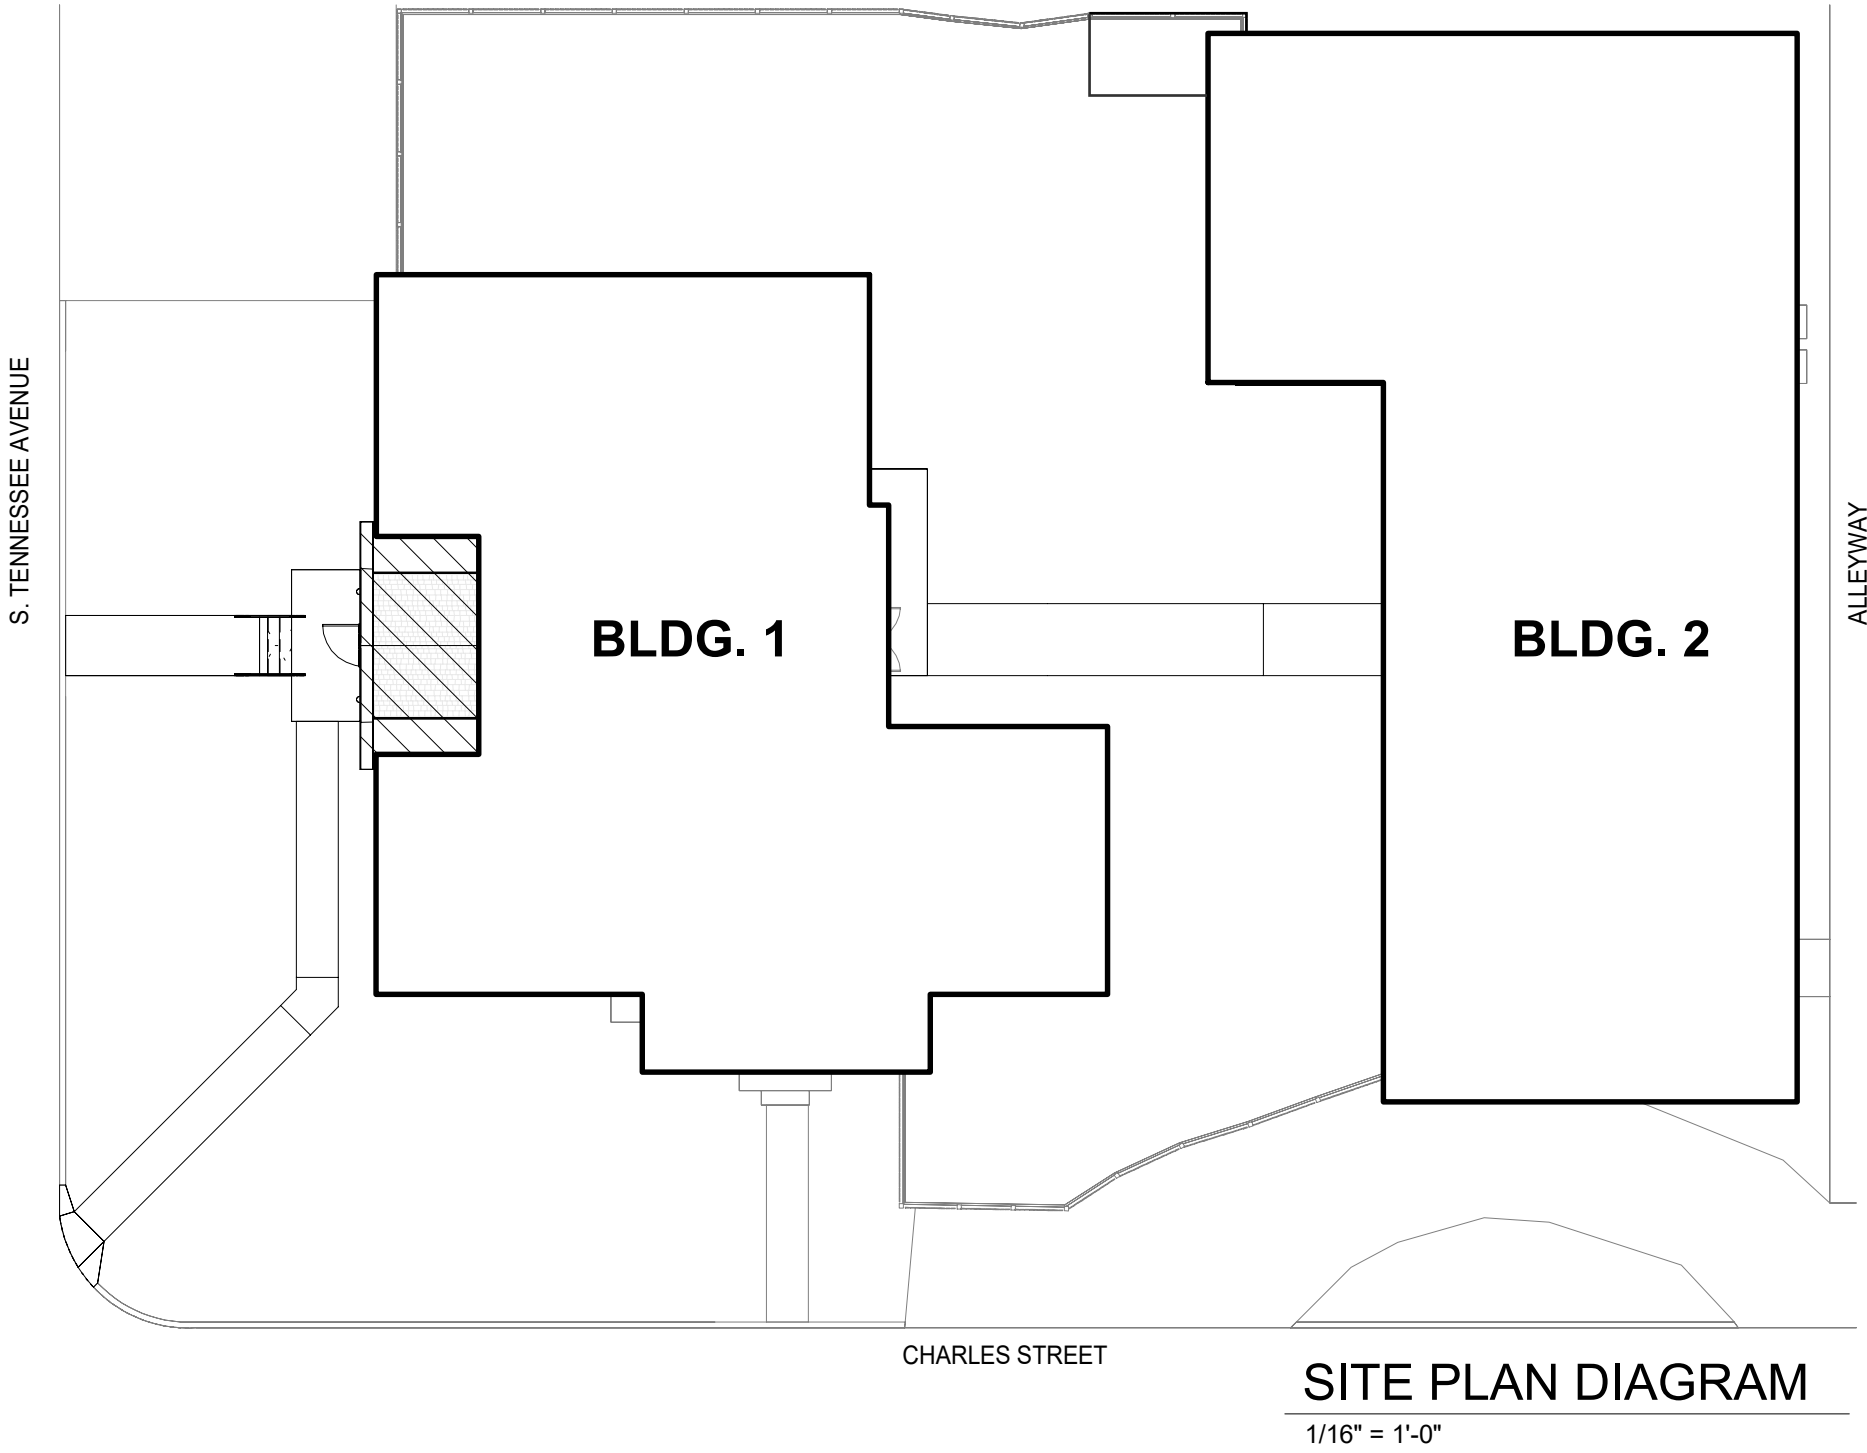
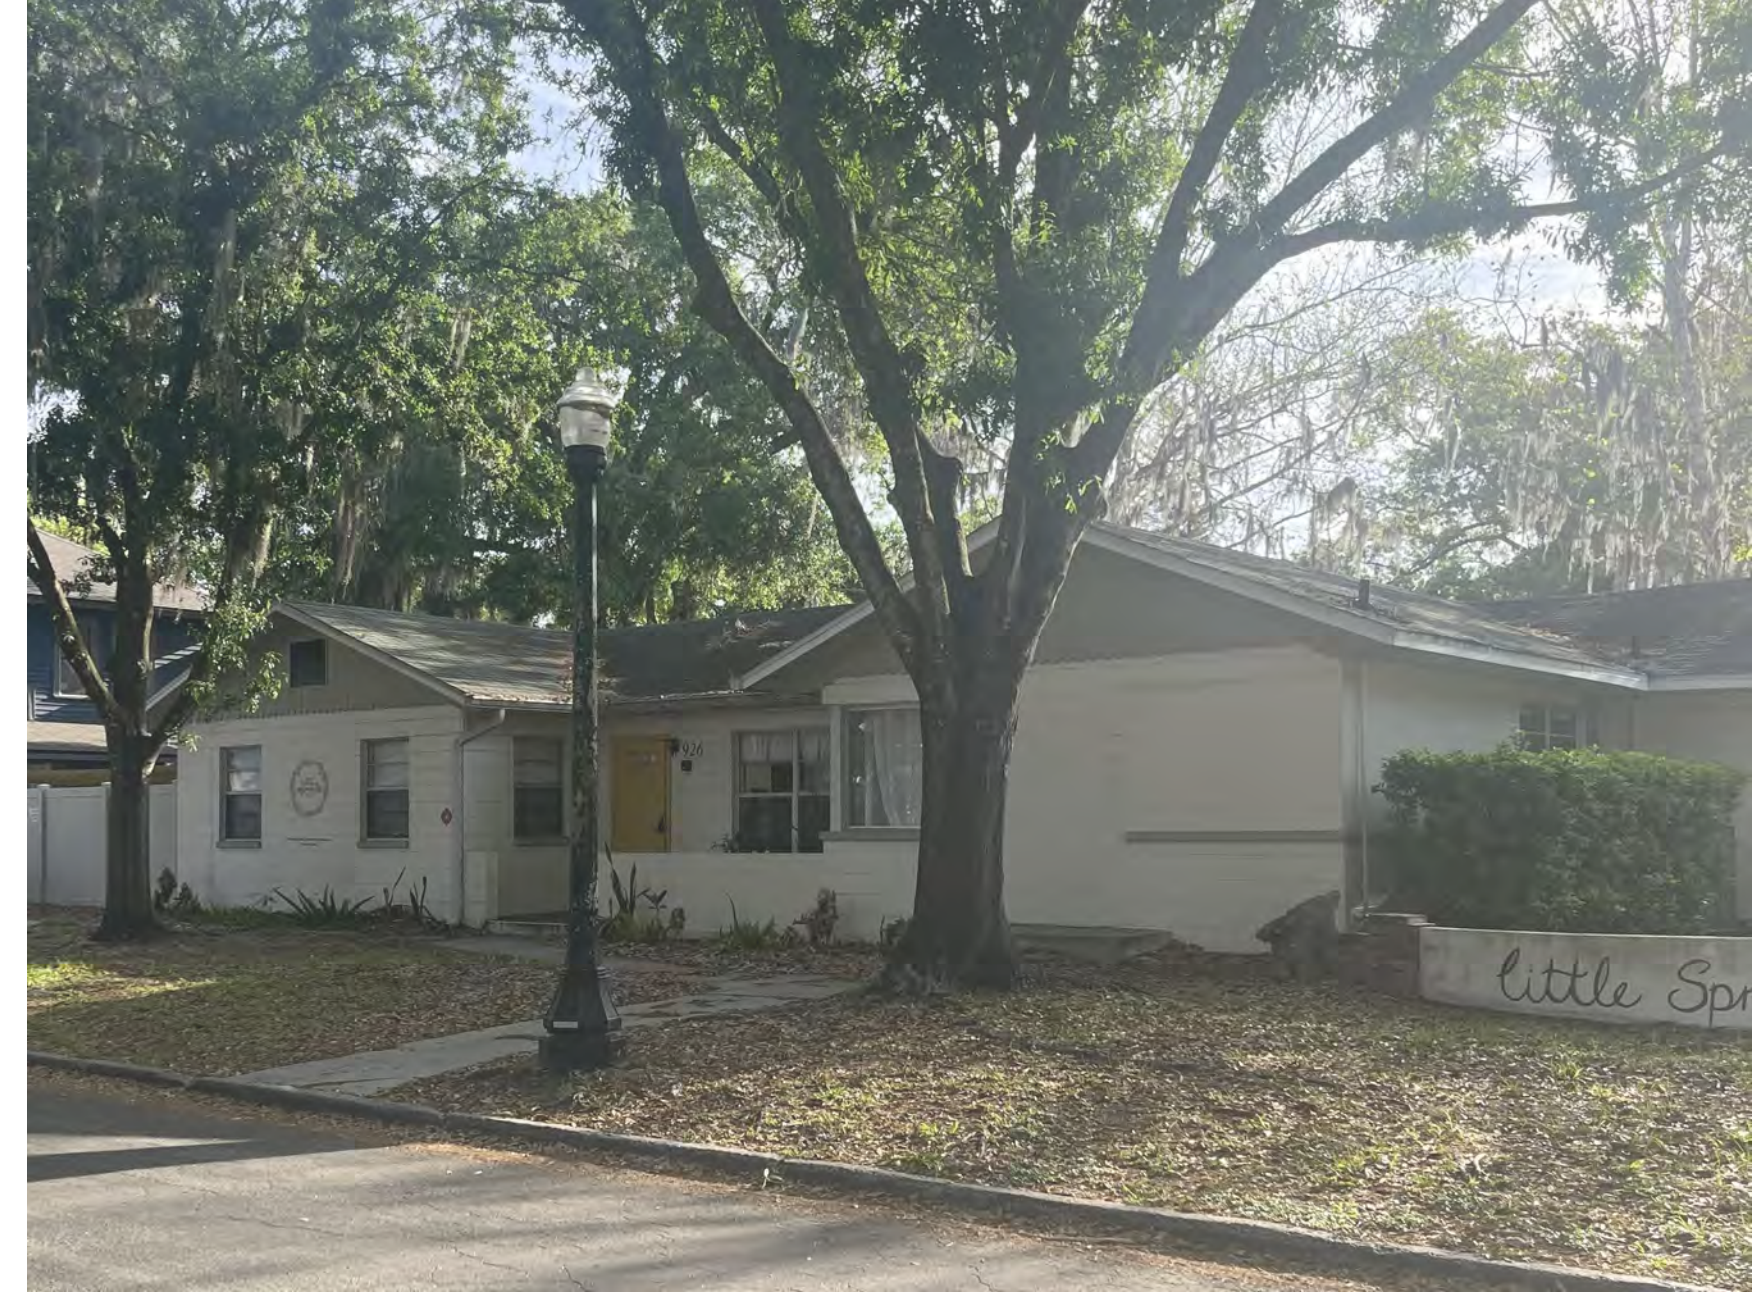
EXISTING BUILDING PHOTO - VIEW OF SOUTH SIDE OF BUILDING 1

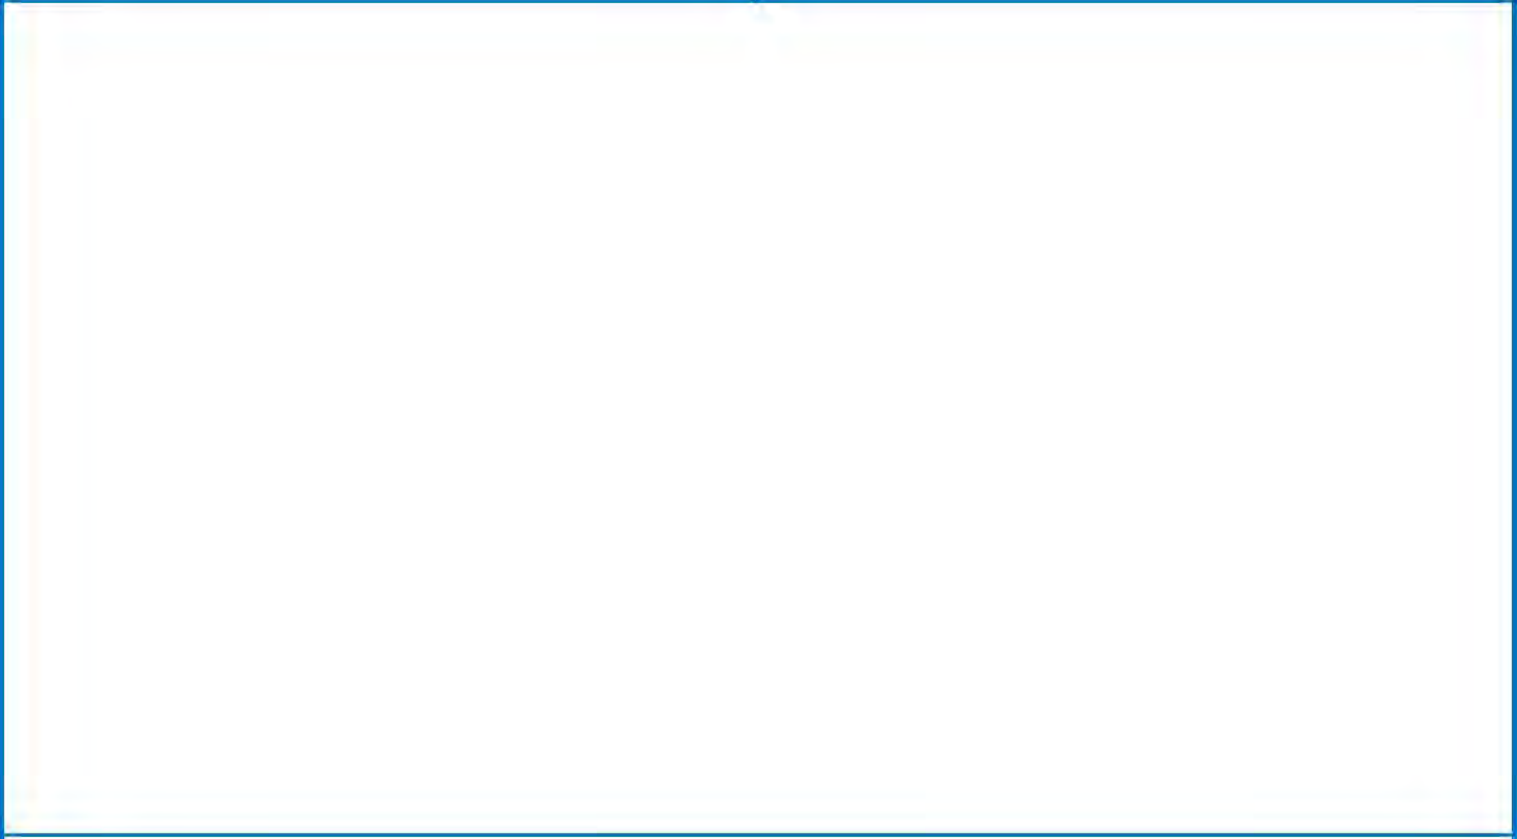
**PLATTED EASEMENTS, NOTABLE OR ADVERSE CONDITIONS (UNPLATTED EASEMENTS ALSO LISTED IF PROVIDED BY CLIENT);
IF APPLICABLE, RECIPIENTS OF THIS SURVEY SHOULD REVIEW THE POSITION OF ANY FENCE LINES SHOWN HEREON AND THEIR RELATIONSHIP TO THE BOUNDARY LINE.**
