WETLAND DETERMINATION DATA FORM - Atlantic and Gulf Coastal Plain Region

Geotechnical Engineering Report

Lake Bonnet Drain Channel
Lakeland, Florida

PROJECT
LAKE BONNET
DRAINAGE BASIN
FLOOD HAZARD AND
DEBRIS MITIGATION -
ELEMENTS 1C AND 3
LAKE BONNET
LAKELAND, POLK COUNTY, FLORIDA

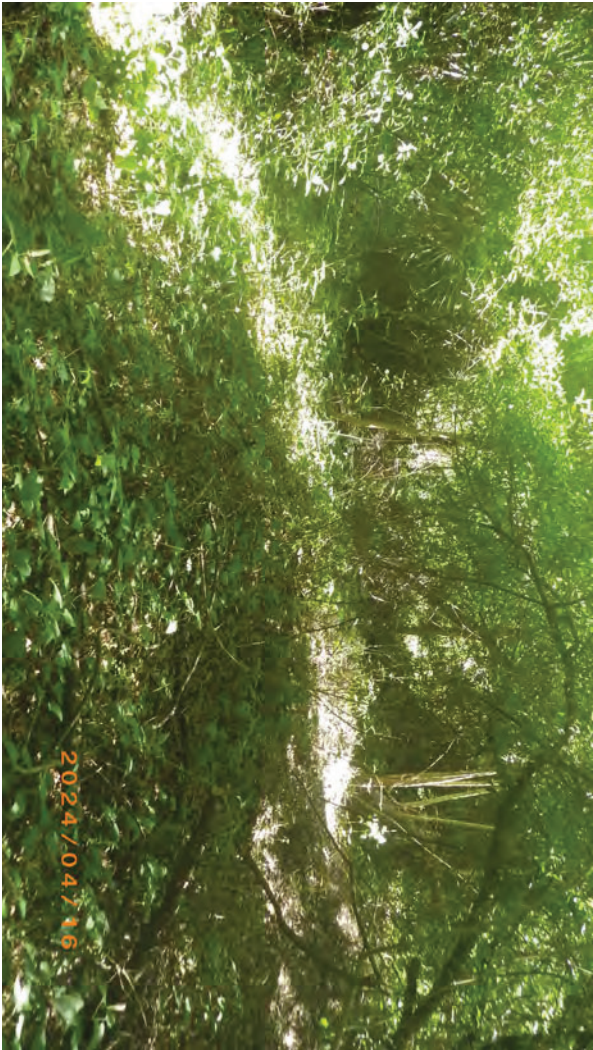
| Description / Comments: Facing south, view of Wetland 05 (W05) adjacent to soil sample pit location. | |

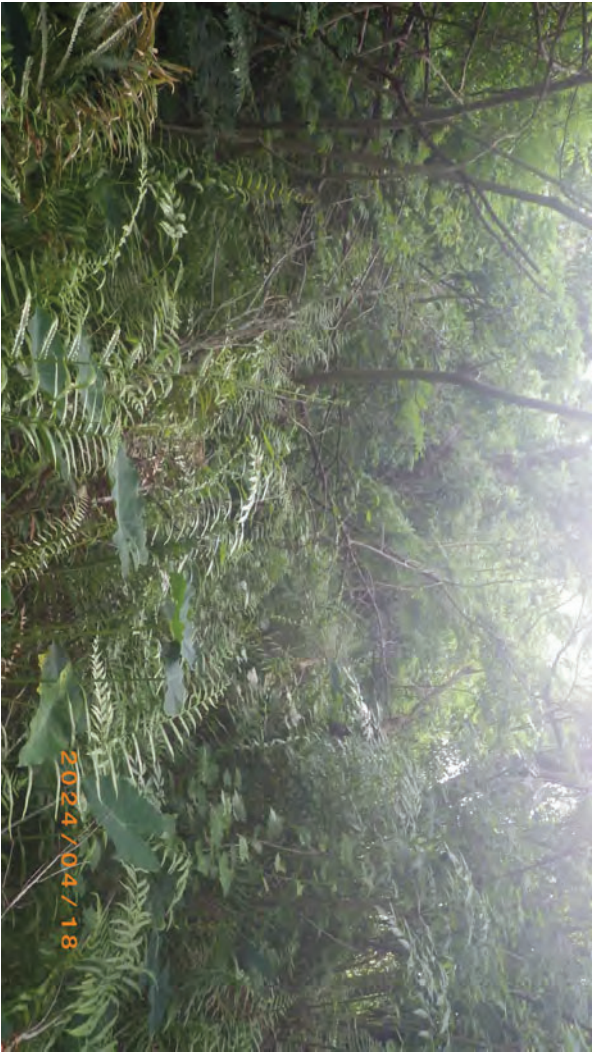
| Photo 7 of 24 | |

| Description / Comments: Facing east, view of Wetland 07 (W07) adjacent to soil sample pit location. | |

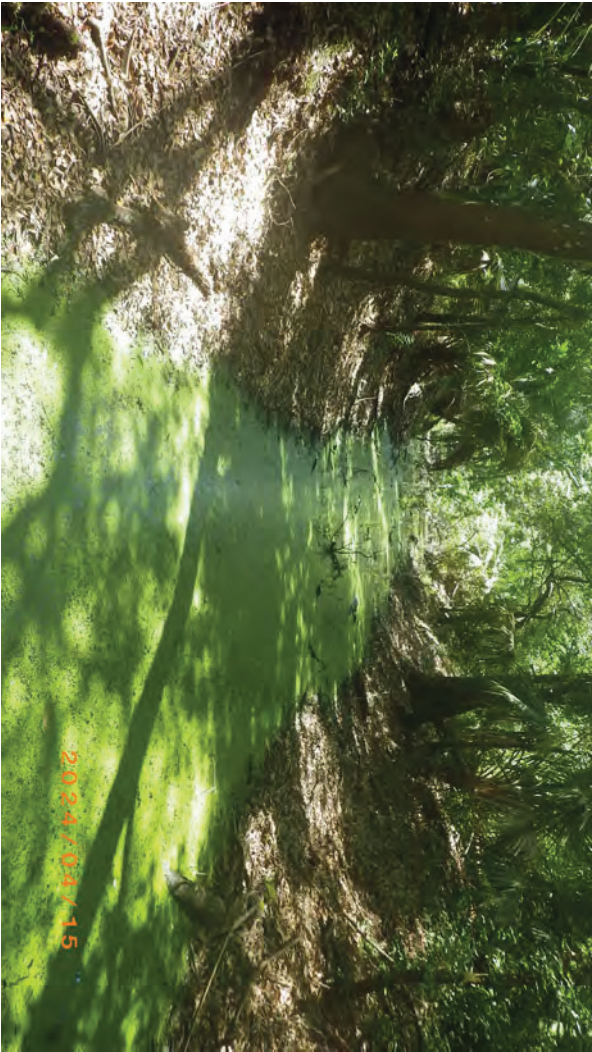
| Photo 14 of 24 | |

| Description / Comments: View of channelized watercourse C02. | |

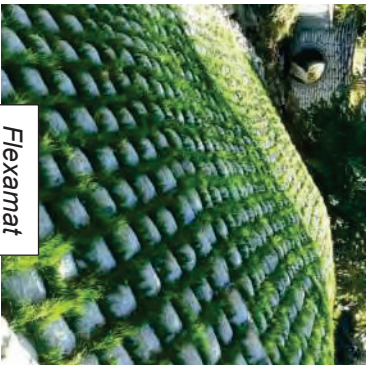
Flexamat

Below are photos of the examples discussed.

A gabion wall system could be another consideration, but space limitations also make constructability a potential issue. It is possible that a stacked Geo-Cell wall or other MSE systems could work and may require less encroachment into adjacent properties if designed as a gravity system. Other gravity systems such as Redi Rock provide aesthetically pleasing alternatives that typically do not encroach as far back as MSE wall systems. Hard armoring using articulated block systems vary from robust systems such as Shore Block to moderate systems such as ShoreFlex/Flexamat. Hydroturf is a more aesthetically pleasing erosion control mat that can be used in applications where seepage behind the system is not a concern.

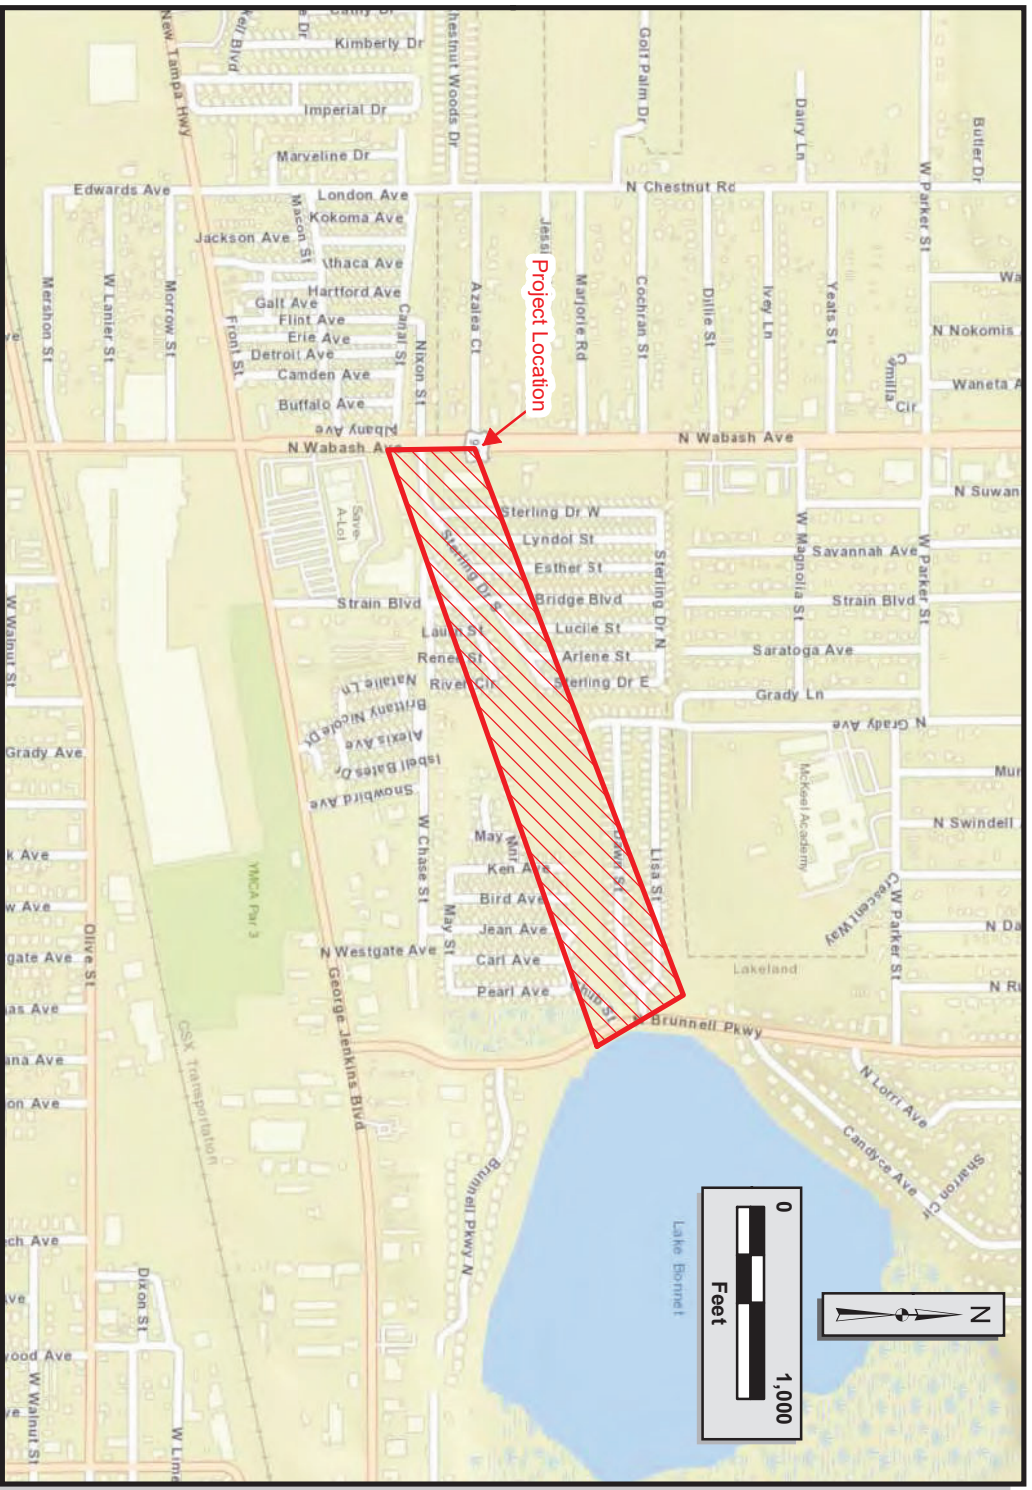
FIGURE 2

| Figure 2 | USGS Topographic Map |

The topographic survey map published by the United States Geological Survey (USGS) was reviewed. Based on this review, the natural ground surface elevation at the project site varies between approximately +140 feet to +145 feet North American Datum (NAD, 1983), which generally agrees with the topographic information/survey data provided by the Client. GIS topographic information is provided on **Figure 2, USGS Topographic Map**.

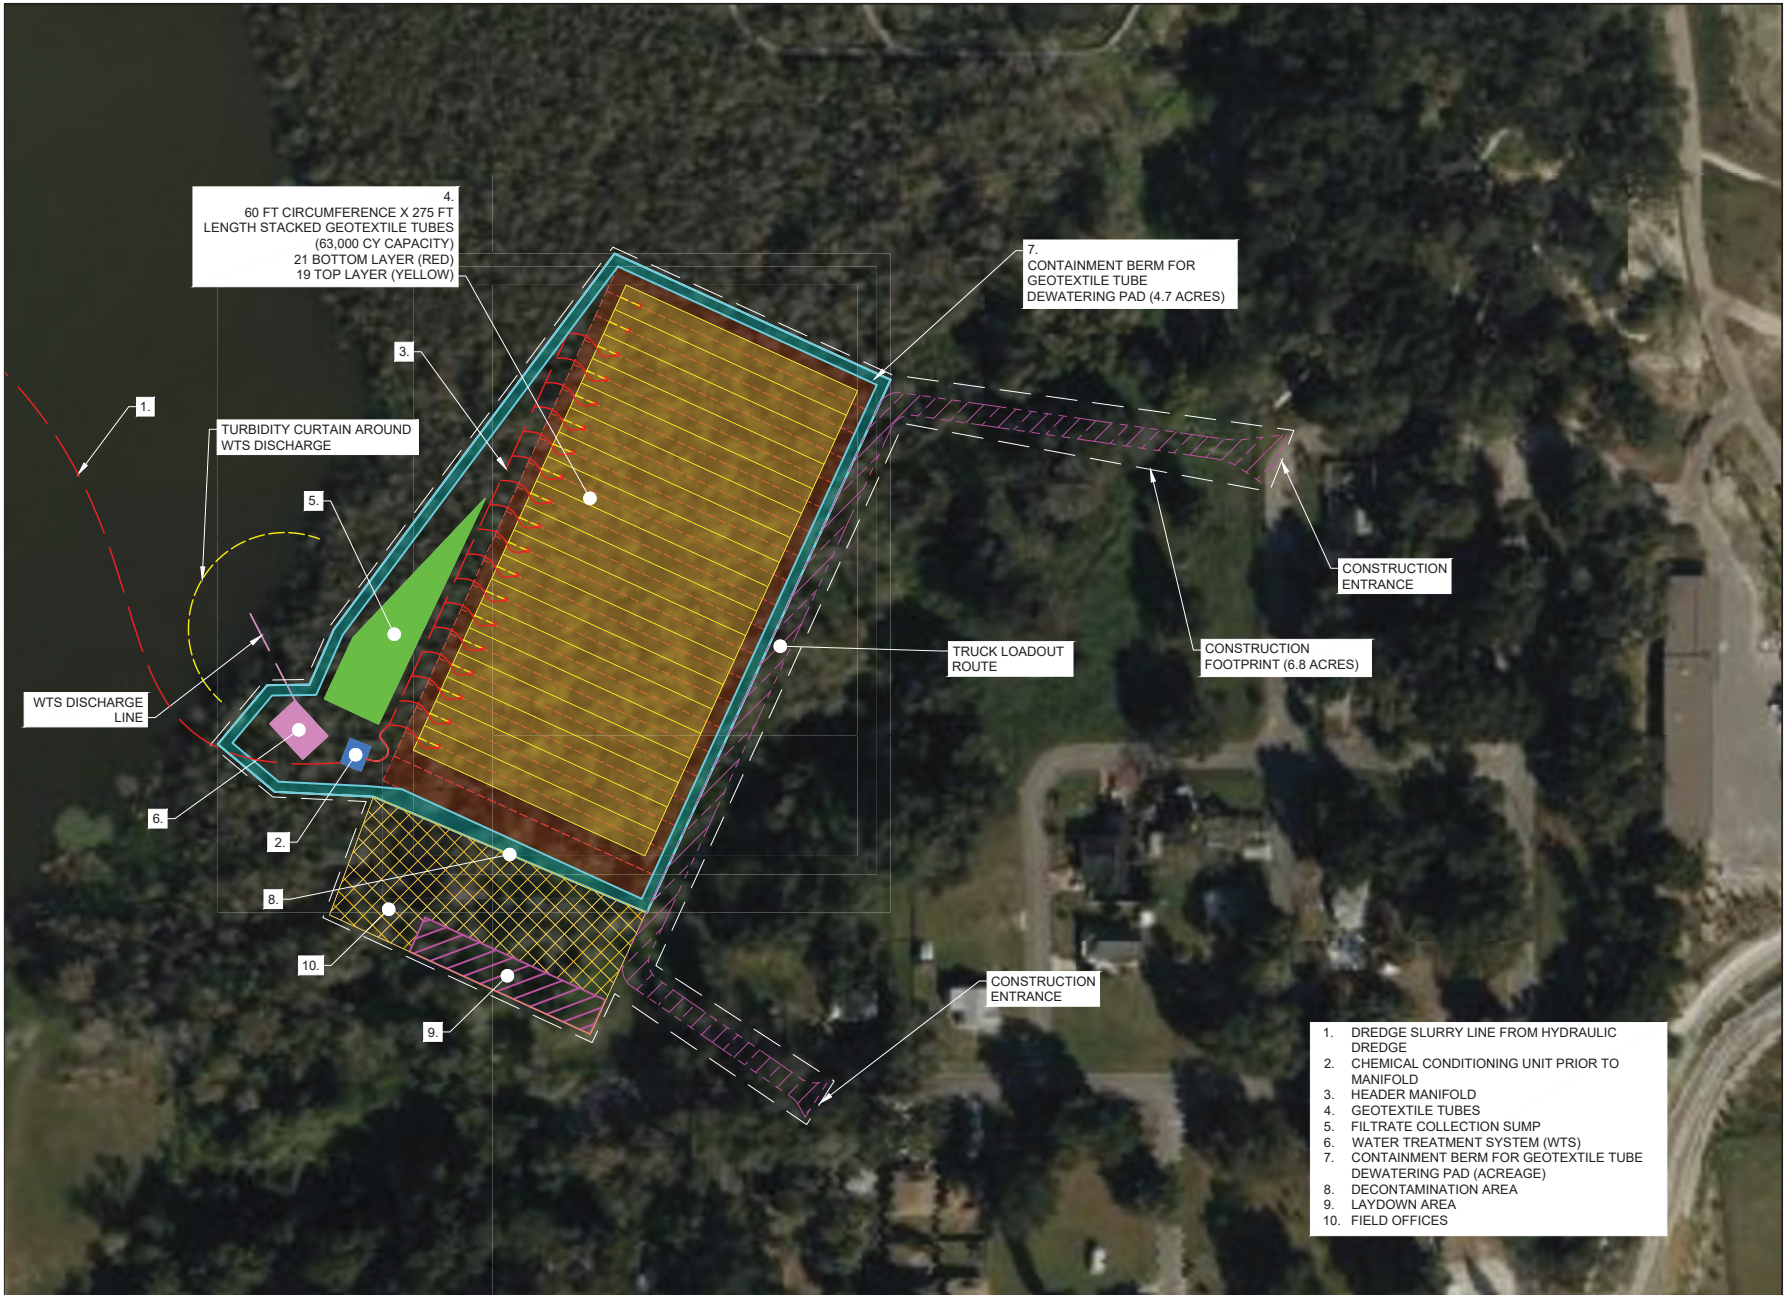
SHEET NUMBER
FIGURE 2

SHEET TITLE
CONCEPTUAL SEDIMENT
DEWATERING PLAN
