AGENDA
HISTORIC PRESERVATION BOARD
Lakeland City Hall, City Commission Chambers
May 28, 2026, 8:30 A.M.

Report of Limited Visual Structural Condition Survey

**120 S Florida Avenue
Lakeland, Florida**

Report of Limited Visual Structural Condition Survey
120 S Florida Avenue
Lakeland, Florida
BillerReinhart Project No. 17-404

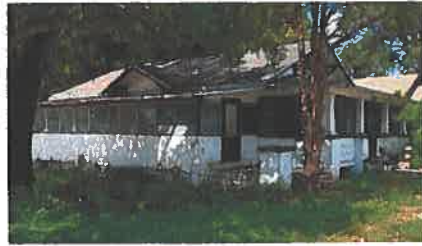
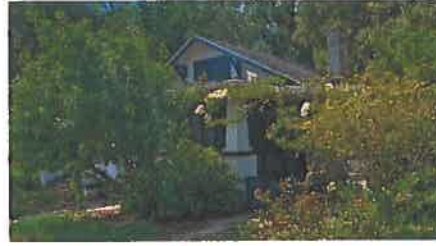
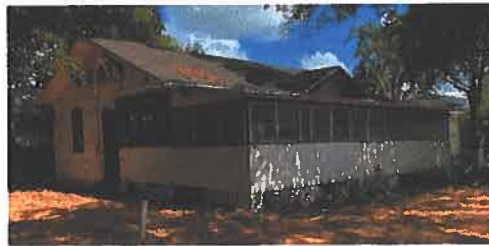
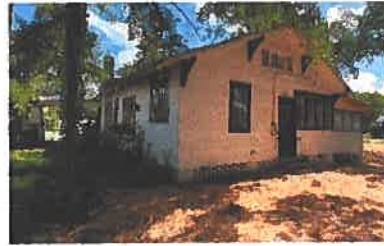
A visual inspection was conducted on this house on 06/25/2025 and the overall condition of the house was below average condition, even for age due to WDO activity.

We were limited in our ability to do a detailed inspection because of evidence that the ceiling and floors were dangerous. Each dross pile is a separate termite (drywood) colony. When there are as many termite colonies that are as visible as they are in this house, approximately a foot apart, there is extensive damage in the attic. The floor was also greatly damaged in areas from WDO activity that when you pressed on them, you could feel the floor give way and some areas if you pressed any harder the floor would cave.

Only professionals very familiar with working in houses that are heavily damaged by termites should be allowed to enter the house. Others should not be allowed into the house until the house is signed off as safe to enter.

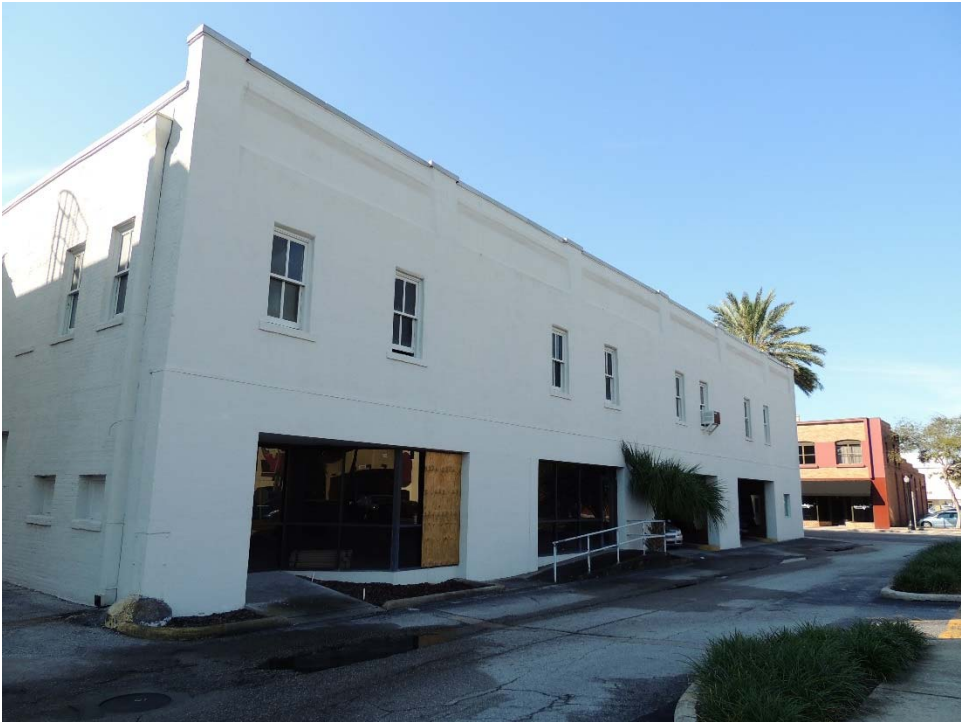
Figure A- 1

1. North elevation is depicted in *Figure A-1*.
2. Numerous areas of cracking were noted in the stucco on the north, west and south elevations.
3. The roof drainage downspout on the south end of the east elevation has detached from the brick substrate.
4. Separation of window frame to brick substrate at the south second story window on the east building elevation was noted.
5. Bricks and mortar joints on the east elevation exhibited cracking of various widths and lengths.
6. The parapet at the east end of the north elevation is visibly tilting to the south.
7. The ceiling/soffit of the drive-through teller areas exhibited cracking of various widths and lengths.

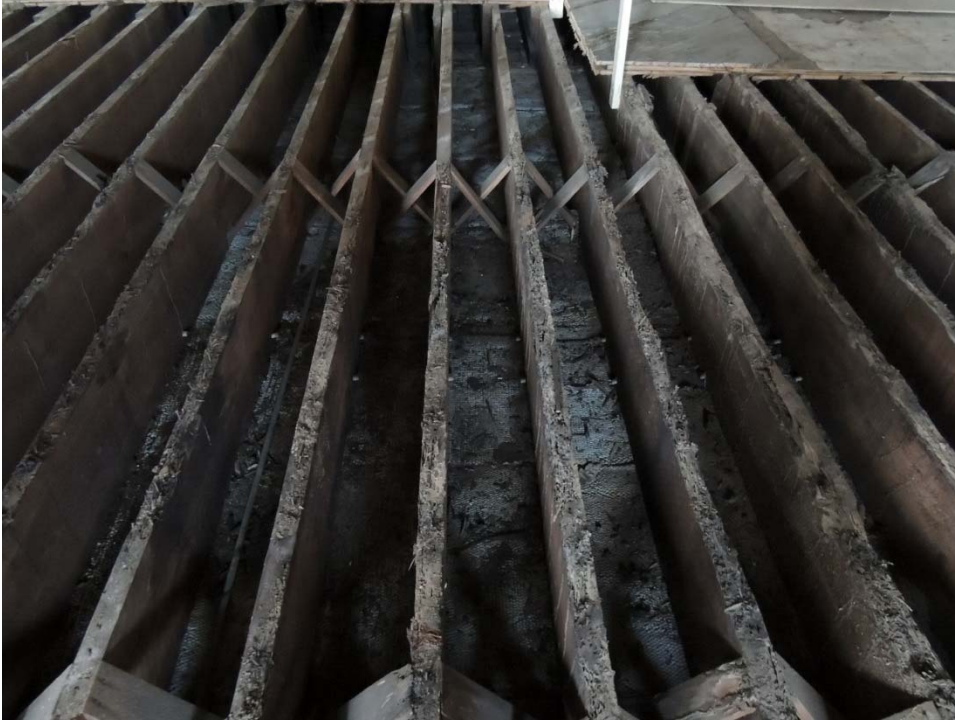
Figure A- 3

- c. Rows of timber cross-bridging were observed between the joists. Refer to *Figure A-3*.
 - d. Two to three layers of tongue-and-groove floor boards spanning over the joists were noted. Refer to *Figure A-6*.

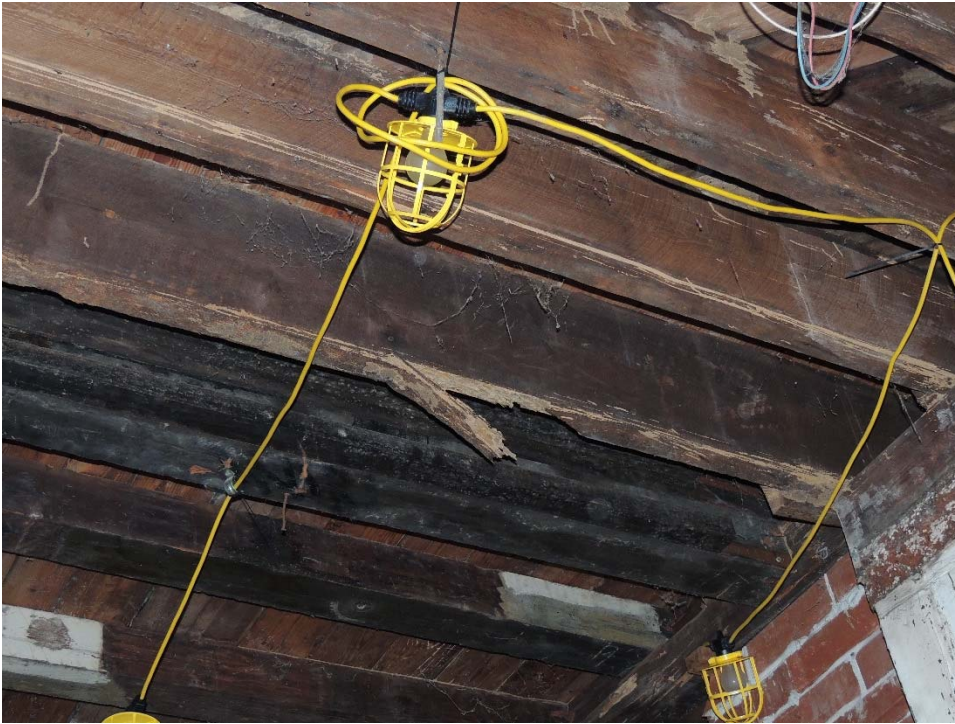
Figure A- 9

- b. The undersides of exposed second-floor joists spanning in the north-south direction exhibited insect related damage. Most of the damage observed was extensive with section loss of the joists. Refer to *Figure A-9*.

BillerReinhart believes that the damage observed on the second floor of the subject building is primarily due to wood destroying organism (insect) activity. Insect related deterioration of wood members is often greater within the member section as compared to that visible on the member surface. BillerReinhart recommends the building remain unoccupied due to the severe loss of structural capacity of the second-floor framing system.

1. Retain and implement the services of a qualified insect control company specializing in the abatement of wood destroying organisms.
2. Retain and implement a shoring plan for the exterior walls to accommodate the full removal and replacement of the second-floor timber system.

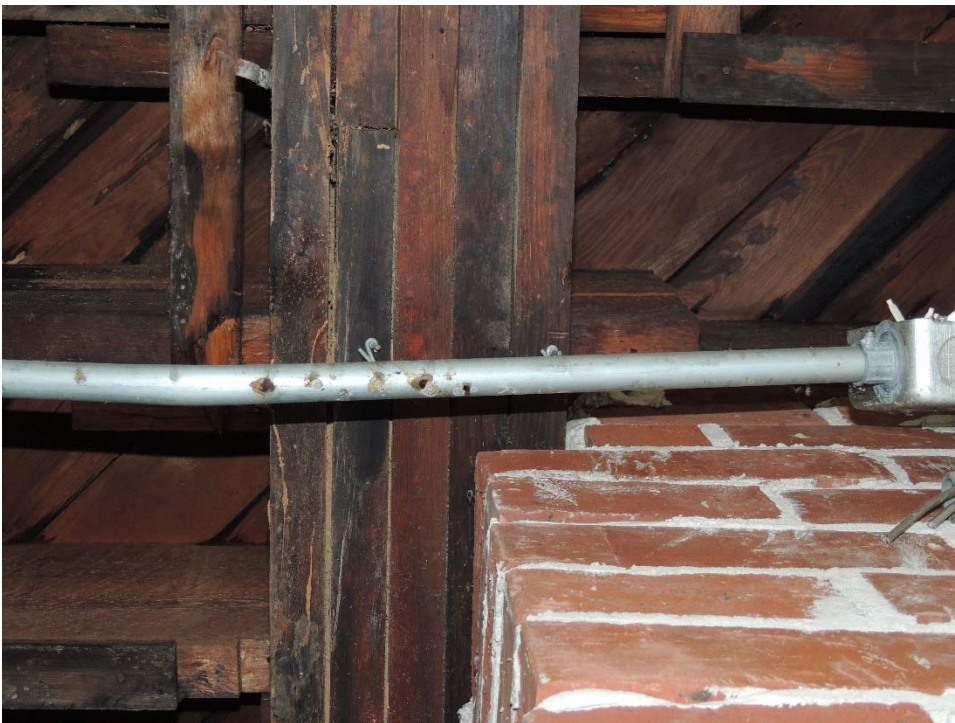
Figure A- 10

- c. Portions of the exposed multi-ply timber beams spanning in the east-west direction exhibited insect related damage. Refer to *Figure A-10*.
 - d. The timber truss and multi-ply timber beams spanning in the east-west direction along the north wall of the hallway space appear to be a load-bearing line for the second-floor joists. Refer to *Figure A-11*.
