CITY OF LAKELAND

Adopted (12/17/2020)

DESIGN GUIDELINES FOR HISTORIC PROPERTIES

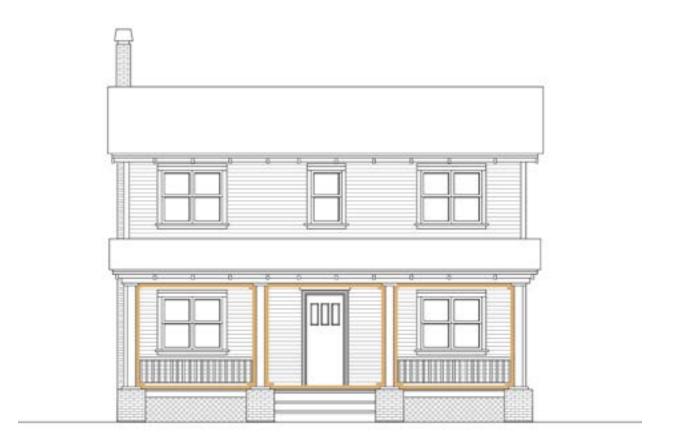
Figure 4.18: Regular Arrangement of Porch Columns and Wall Openings

The way columns are placed on a porch, fenestration patterns of windows and doors and other façade features defines the structure's perceived rhythm and order from the street. This layered condition, which often defines symmetrical facade conditions, is also one of the most prominent visual compositions that expresses a unique architectural style. New infill structures and porch additions should interpret these as precedent conditions and reflect porch column and fenestration patterns that work in conjunction with each other as major façade compositions.

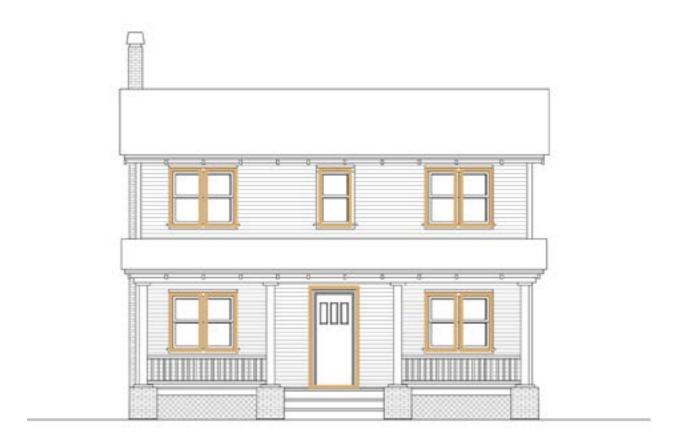
Figure 4.20: Acceptable Window Configurations

trim features. Windows should be configured vertically or square with height to width proportions ranging from 1:1 to 3:1. These proportions are often based on the human body and reflect the window patterns of adjacent historic structures. The many window options available today are primarily constructed of wood, clad-wood or a synthetic material such as vinyl. Regardless of materials used, windows in new infill structures that use traditional design features, should be indiscernible from wood windows at about four feet away.

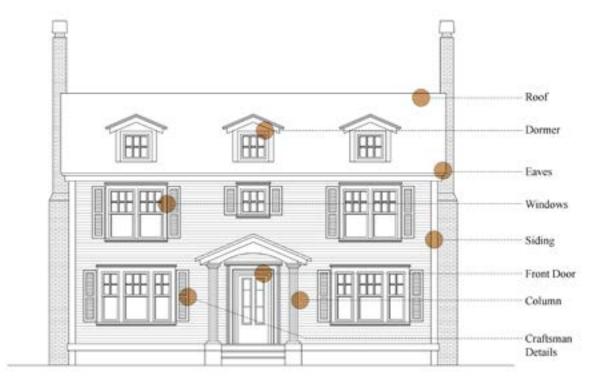
Figure 5.12: Colonial Revival Facade Features

The Colonial Revival style was introduced at the Philadelphia Exposition of 1876. This celebration of the centennial of the United States fueled a nostalgia for early America and sparked a renewed interest in the architecture of the colonial period. There are three basic types of Colonial Revival buildings: the historically accurate reproduction of 17th century Georgian and Federal styles; the Colonial or Classical elements applied to Victorian or Post-Victorian buildings, and lastly, simple vernacular homes with Colonial details. The typical Colonial Revival house in Florida, which emerged in the late 1880s, is a mix of several colonial designs rather than a direct copy of a single style. Colonial Revival is typically two stories with a front porch stretching the length of the building or simple entry porches (some buildings may have porches in the rear). The façade is symmetrical with an entrance stair centered on the main façade and classical columns spaced evenly across the front. Like other historic structures, the Colonial Revival is supported by brick (earlier periods) or concrete (later periods) piers that are spaced out to allow for ventilation and for protection from high water. The exterior is typically made of horizontal wood siding and is decorated with pediments, broken pediments, and wood shutters. The doors have a simple classical trim and are often flanked by fixed glass sidelights. The windows have simple trims and are sometimes framed by wooden or wrought iron grills. The windows are paired double-hung wood sash with 6/6 or 2/2 divided panes. Colonial Revival either has a gable, hip, or gambrel primary roof with the porch roof being a shed or low-sloped configuration. Dormers with hip, gable or shed roofs are a defining characteristic with rafter ends typically exposed and decoratively cut. The roof is covered with composition shingles or occasionally metal roof coverings. All chimneys are brick with simple coursing, shoulder and corbel details.

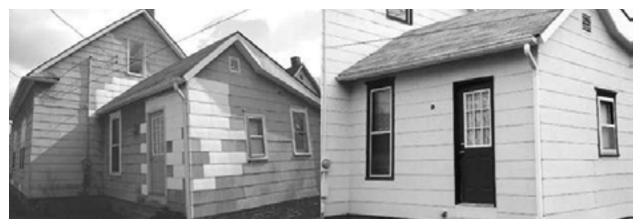
Figure 8.6: Replacement non-asbestos fiber-cement shingles in place, before being painted and after (photo by author).

Figure 8.6: Replacement non-asbestos fiber-cement shingles in place, before being painted and after (photo by author). 292
